APOLLO SPACECRAFT FLIGHT HISTORY

This section contains a discussion of the significant problems or discrepancies noted during the Apollo 12 mission. Anomalies in the operation of experiment equipment after deployment will be published in a separate anomaly report.

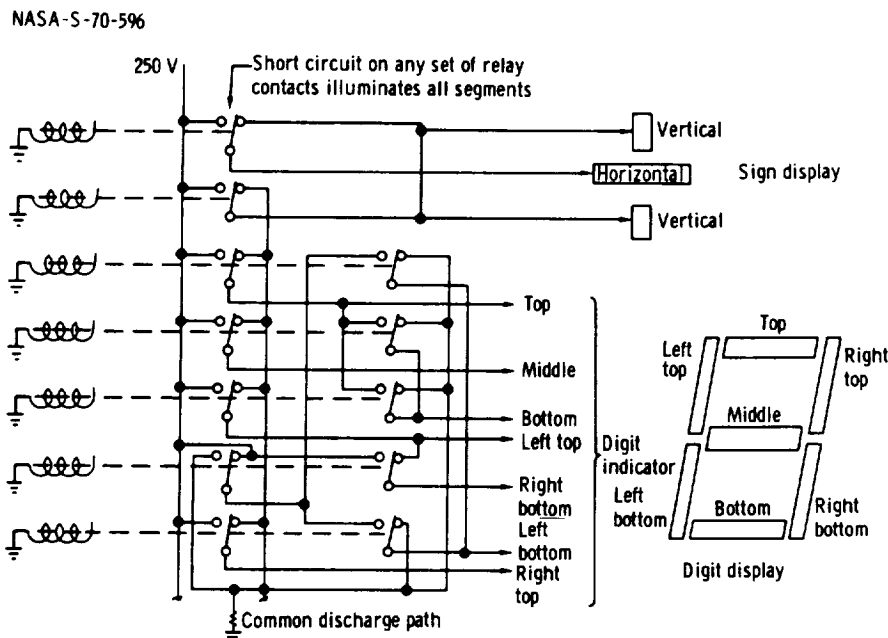
The crew reported several intermittent, all-"8's" displays on the main display and keyboard assembly approximately 1-1/2 hours before launch, but no display malfunction occurred in flight. The display segments are illuminated by applying 250 V ac through the contacts of miniature relays, as shown in figure 14-1. When a segment is off, it is grounded through a resistor and the normally closed contacts of a relay to avoid residual illumination. The normally closed contacts of all relays are tied together; consequently, a short across the contacts of any one relay will apply the voltage to all segments of each display. The effect of the short in conjunction with the common discharge path is shown in figure 14-1 for a typical character and one sign. A short across the relay contacts will affect only the display function of the unit.

Figure 14-1. - Simplified schematic diagram of relay matrix.

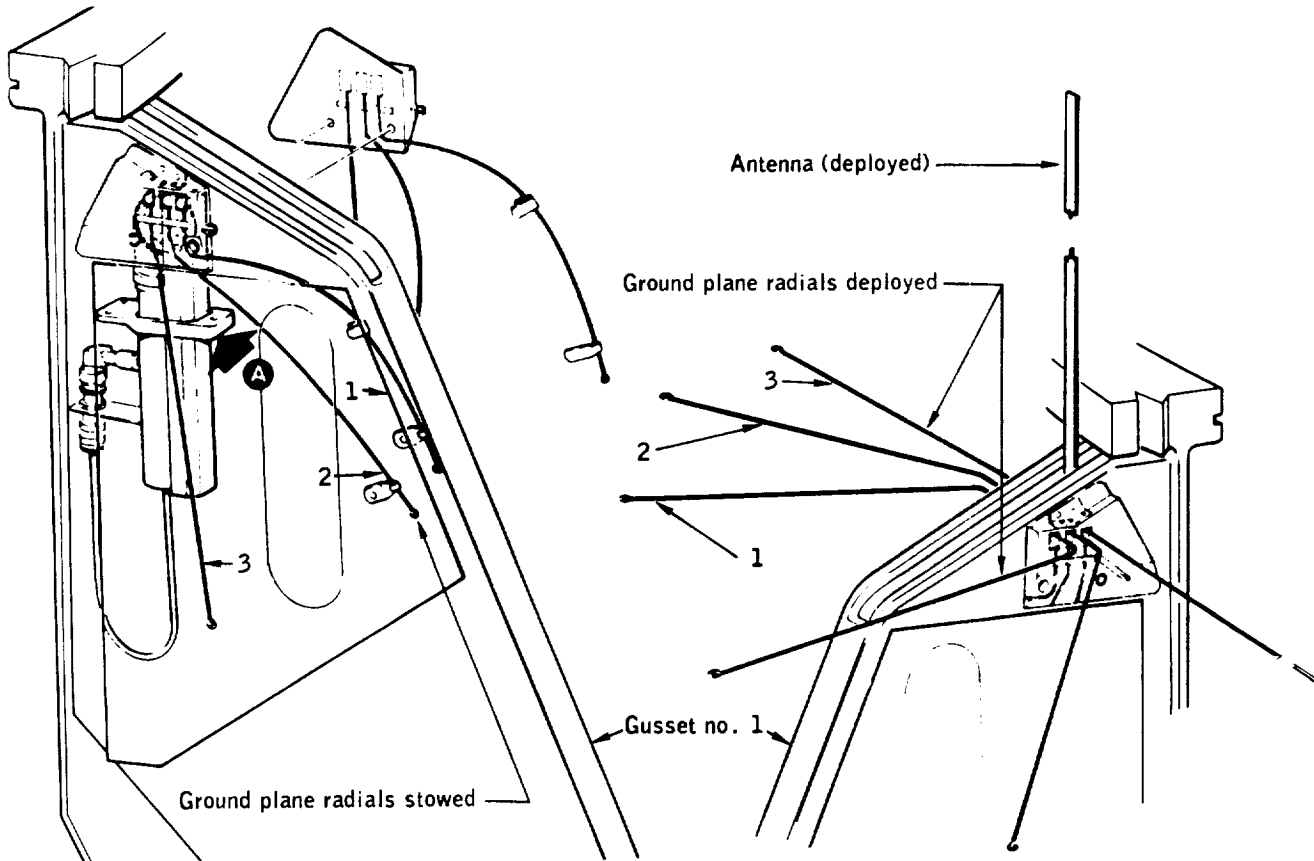
During the command module descent on the main parachutes, ground plane radials 1 and 3 of VHF recovery antenna 2 (fig. 14-15) did not properly deploy. However, voice communications with the recovery forces while using this antenna were not significantly affected. Postflight examination of the antenna revealed that the cloth flap which normally covers the radials to prevent entanglement with the parachutes could be made to stick to the gusset by an adhesive substance which was inadvertently present on both the flap and the gusset. The radials would not deploy when the flap had stuck to the gusset; however, radial 1 would not always deploy, even when the flap was not stuck. A slight binding at the spring end or at the retaining clip has been experienced on radial 1.

Figure 14-15.- VHF recovery antenna configuration.

For Apollo 13 and subsequent missions, recovery antenna 2 will be used for recovery beacon transmissions instead of voice. However, even

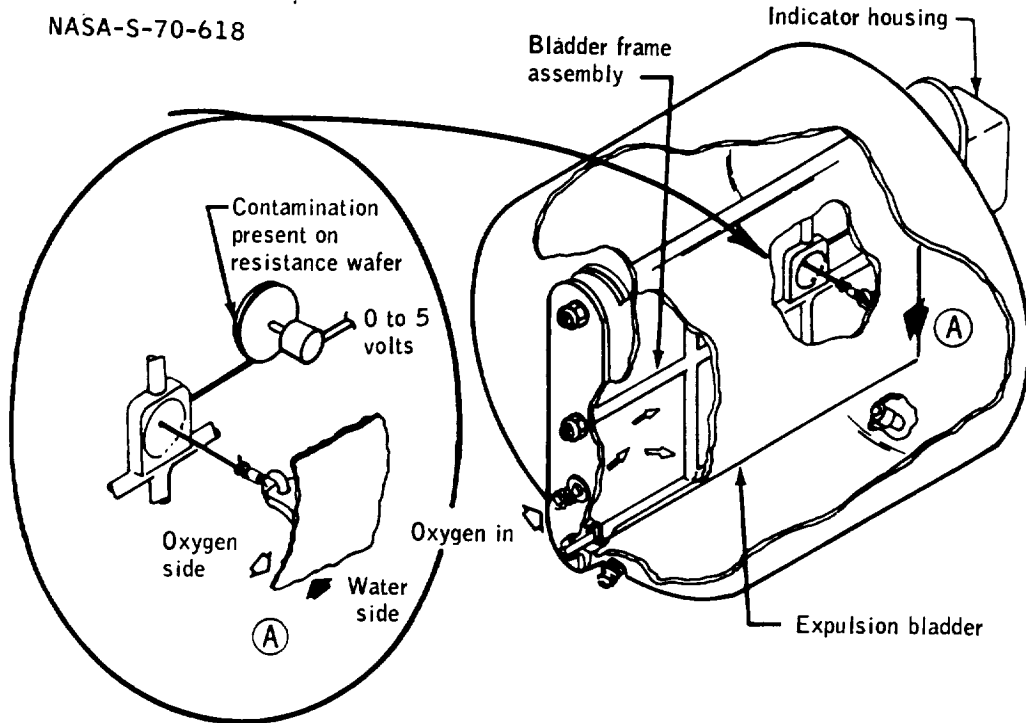
Figure 14-23.- Area of failure in erratic potable water transducer.
