APOLLO 14 MISSION REPORT

MANNED SPACECRAFT CENTER

MAY 1971

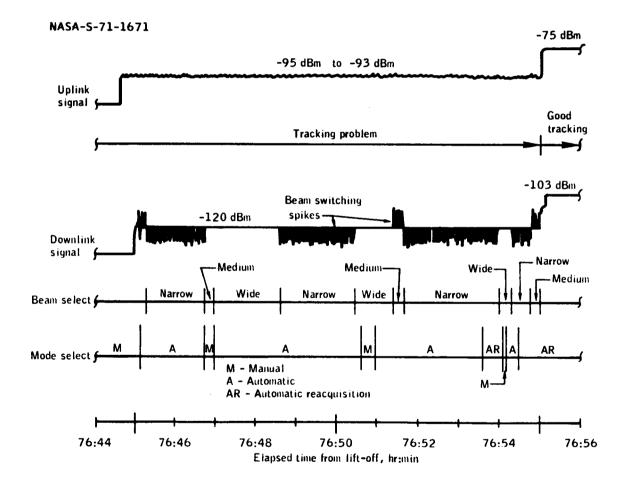
Figure 14-3.- Data from first period of anomalous operation.

The ground data signatures which show the first acquisition and tracking problems are illustrated in figure 14-3. The antenna started tracking a point approximately 5 to 8 degrees off the earth pointing angle at 76:45:00 elapsed time and continued tracking with low uplink and downlink signal levels for 10 minutes at which time a good narrow beam lock-up was achieved.

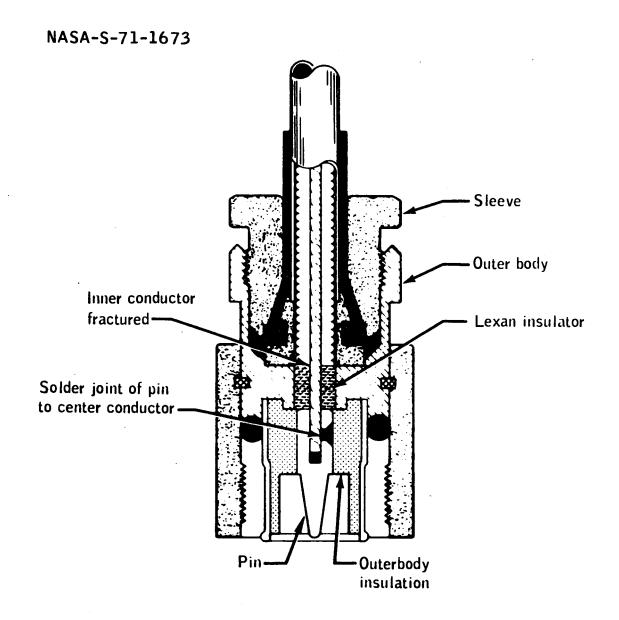
Figure 14-5.- Coaxial cable failures.

Note: A slip fit is required between the pin and insulator so that the pin does not rotate when turning outer body during assembly of the threaded sleeve.

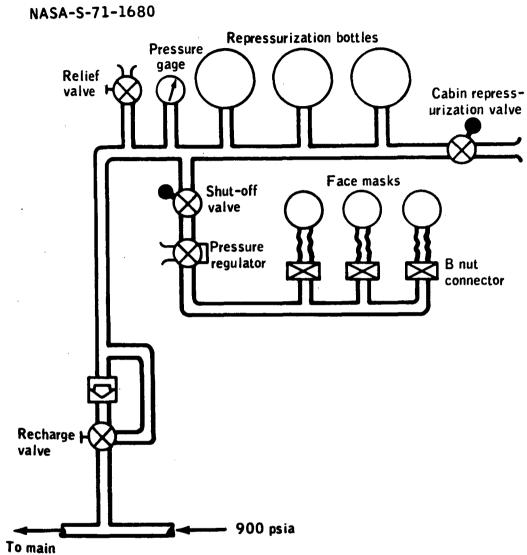
Figure 14-12.- Rapid repressurization system.

Repressurization of the three storage bottles in the rapid repressurization system (fig. 14-12) was required three times in addition to the normal repressurizations during the mission. The system required repressurization once in lunar orbit and twice during the transearth coast phase. Just prior to the first of the transearth coast repressurizations, the system had been used (face mask checks) and refilled (fig. 14-13). In this instance, the fill valve was closed before the system was fully recharged. Calculations from the surge tank pressure data indicate that the repressurization package was at approximately 510 psi at 199 hours 48 minutes and was only recharged to about 715 psi (fig. 14-13). The cabin indication of the repressurization package pressure would have indicated a higher pressure because of the temperature rise of the compressed gas. The crew noted a value of about 700 psi (due to temperature stabilization) at approximately 211 hours and recharged the system again.

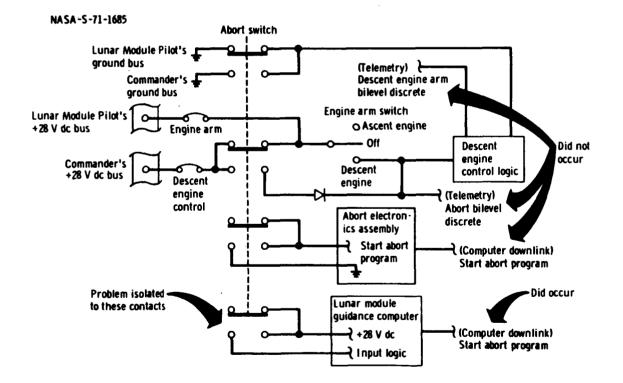
Figure 14-17.- Abort switch logic.

Prior to descent, the primary guidance computer received an abort command four different times. The computer would have reacted if the descent program had been initiated. The failure was isolated to one

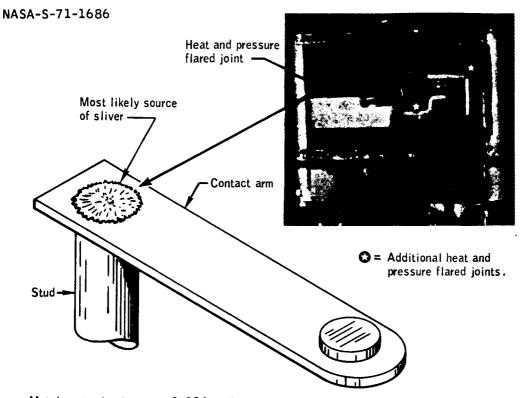
Figure 14-18.- Abort switch contamination.

Metal contamination up to 0.030-inch long slivers found in several switches (a) Simplified sketch of internal switch parts.

(b) X-rays of switch showing metallic contamination.

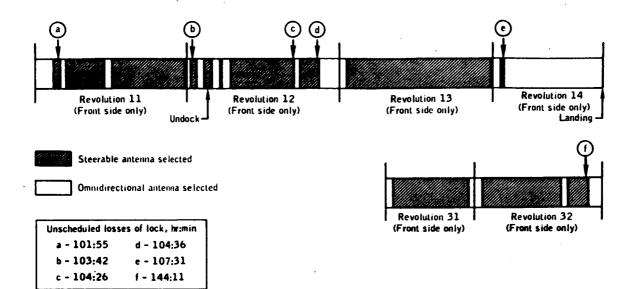
Figure 14-19.- S-band steerable antenna operation.

The remaining unexplained tracking interruptions (fig. 14-19) have similar characteristics. Five tracking interruptions occurred during Goldstone coverage and figure 14-20 is a plot of ground-station-received signal strengths at these times. During the Madrid ground station coverage of revolution 32, another incident was noted with the same type of NASA-S-71-1687

antenna response. It indicates that the antenna began to experience a mechanical oscillation of approximately 2 to 3 hertz, which became increasingly larger in amplitude until the antenna lost lock. When antenna oscillations exceed plus or minus 5 degrees, excessive motor drive current causes the 28-volt dc circuit breaker to open and the antenna ceases to track. The crew reset this circuit breaker several times. The antenna was also reported to be noisy, indicating the continual driving that would have occurred during the oscillations. The oscillations occurred randomly at other times during the problem period, but damped out and did not cause tracking interruptions.

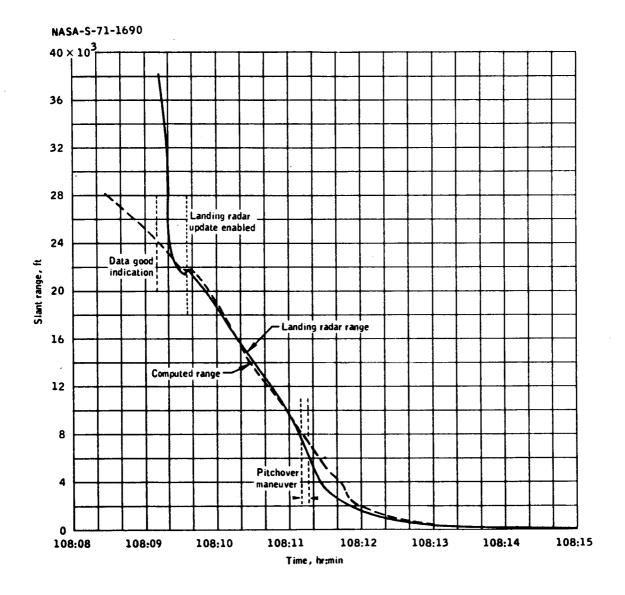
Figure 14-22.- Comparison of measured and computed slant range during powered descent.

The second condition which was not expected occurred after the circuit breaker was recycled. At this time the initial slant range reading was approximately 13 000 feet greater than that calculated from the operational trajectory. Several seconds later, the indicated slant range jumped from 32 000 to 25 000 feet. Subsequently, the landing radar readings compared favorably with the operational trajectory (fig. 14-22).

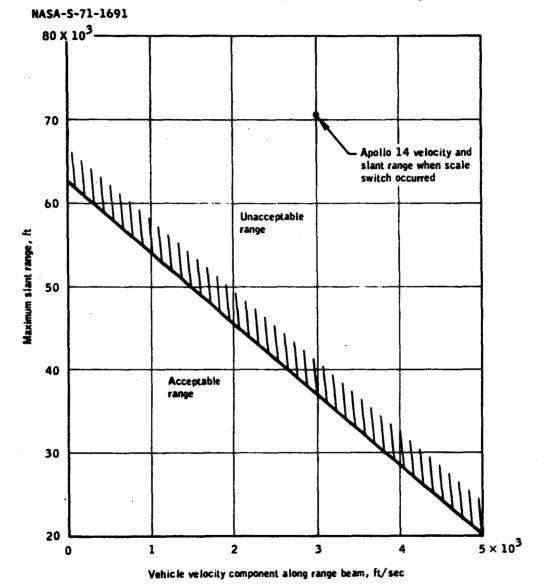
Figure 14-23.- Landing radar range measurement design limitation as a function of vehicle velocity component along range beam.

The scale switching occurred at a slant range of 63 000 feet with a beam 4 velocity of 3000 ft/sec at an incidence angle of 35.4 degrees. Operating the landing radar under these conditions exceeds the maximum range measurement design limit (fig. 14-23). Under these conditions, the receiver is sweeping with maximum gain and the system will be sensitive to any received noise. A test was performed with a radar operating under the Apollo 14 conditions (two range-rate beams locked up and the range beam unlocked). By inserting low-level noise for a fraction of a second into the receiver, range scale switching occurred.

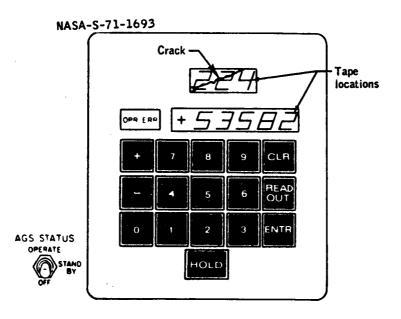
Figure 14-25.- Locations of crack and tape on data entry and display assembly.

The crew reported a crack in the glass across the address register of the data entry and display assembly. Figure 14-25 shows the assembly and the location of the crack. Figure 14-26 is an enlarged drawing of the glass and associated electroluminescent segments.

The cause of the crack is unknown. Glass cracks have not occurred since a revision was made to the procedure used to mount the glass to the faceplate of the data entry and display assembly. The assembly is qualified for an environment in excess of the flight conditions. Therefore, either excessive internal stresses (under normal conditions) were built into the glass, or the mounting was improper (not as designed), or the glass was inadvertently hit.

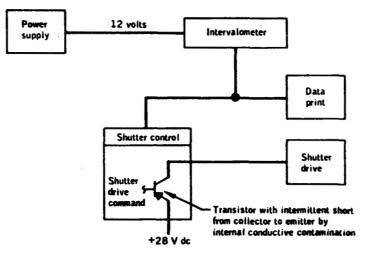
Figure 14-27.- Lunar topographic camera shutter control.

Postflight tests with the flight camera showed satisfactory operation in all simulated environments (pressure, thermal, and vibration) at one-g. An intermittent failure was found in a transistor in the shutter control circuit (fig. 14-27). The transistor was contaminated with a

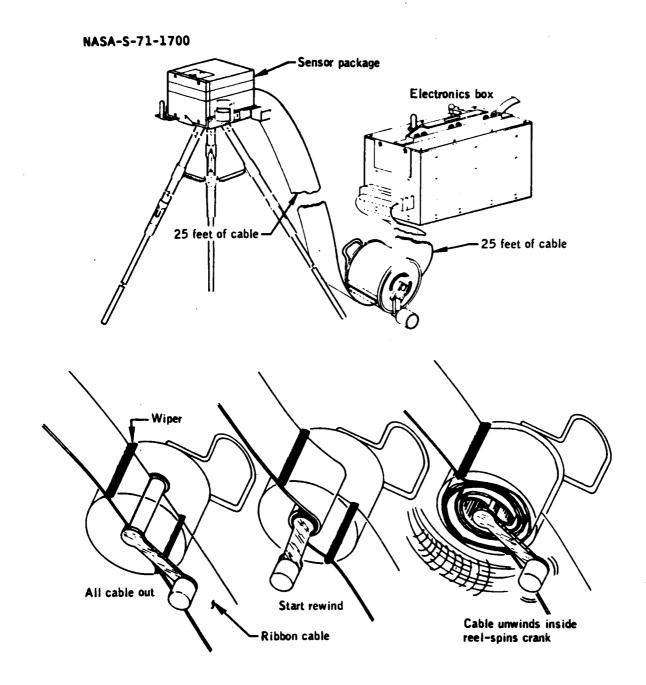
Figure 14-32.- Lunar portable magnetometer cable reel.

The crew reported that it was difficult to rewind the lunar portable magnetometer cable. The cable is deployed and rewound at each location where the lunar portable magnetometer is used (fig. 14-32).

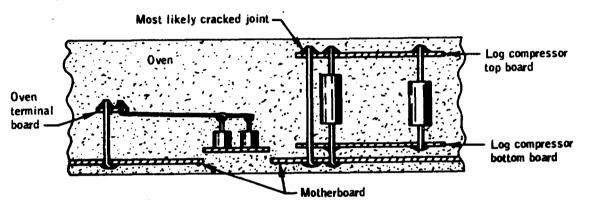
Figure 14-36.- Suspected cracked solder joints in amplifier.

The log compressor modules for geophones 1 and 2 are of the same type construction. Since these are located slightly further from the oven than the one for geophone 3, the maximum temperature may not be quite as high. As a result, it may take longer for them to crack, if at all.

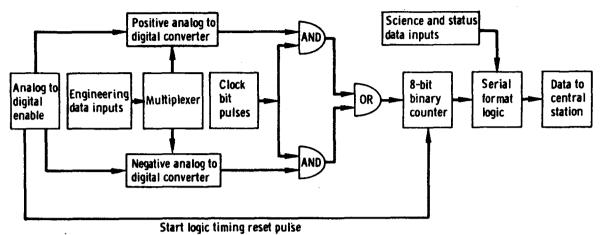
Figure 14-37.- Simplified data logic control.

An intermittent failure of the start reset pulse for the positive log analog-to-digital converter control logic (fig. 14-37) could cause the problem. Although the failure permits the positive converter initial output to fill the eight-bit binary counter and produce a full-scale reading; thereafter, when a start pulse for the positive converter should reset the eight-bit counter, it fails to do so, and the negative word which is still in the counter is read out as a positive word. The cause appears to be an intermittent component or wire connection in one of the associated modules. However, it does not appear to be a function of the temperature. The components have been passed by normal high reliability screening, and systems tests have included operational pressure, temperature, vibration, humidity, and accelerated lunar environment cycles. No failure of this NASA-S-71-1705

type has been experienced with ground tests. No additional testing is considered warranted for Apollo 15, which will be the last mission for the experiment.
