MSC-05161

APOLLO 15 MISSION REPORT

MANNED SPACECRAFT CENTER
HOUSTON, TEXAS
DECEMBER 1971

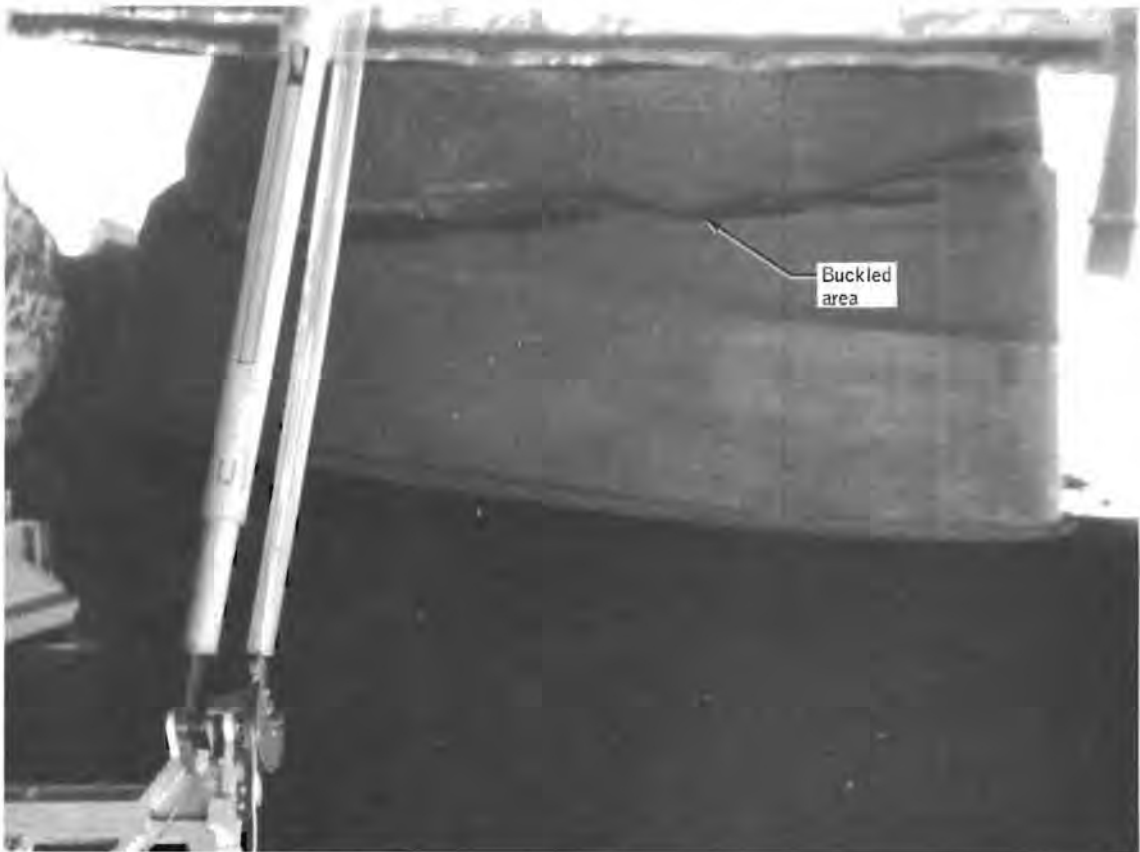
At touchdown, the lunar module was located partially inside a small crater with the rim of the crater directly underneath the descent engine skirt. The descent engine skirt buckled during landing. This is accounted for in the touchdown dynamic analysis, and was expected as the skirt length had been extended 10 inches over that of previous vehicles. This buckling was noted by the crew and confirmed by photographs of the damaged skirt (fig. 7-1). The crew reported that there was a gap between the exit plane of the skirt and the lunar surface, indicating that buckling was probably caused by a buildup of pressure inside the nozzle due to proximity to the lunar surface, and not due entirely to contact of the nozzle skirt with the lunar surface. The crew also reported that the buckling seemed to be uniform around the skirt periphery and that the exit plane height above the surface was uniform.

Figure 7-1.- Buckling of descent engine skirt.

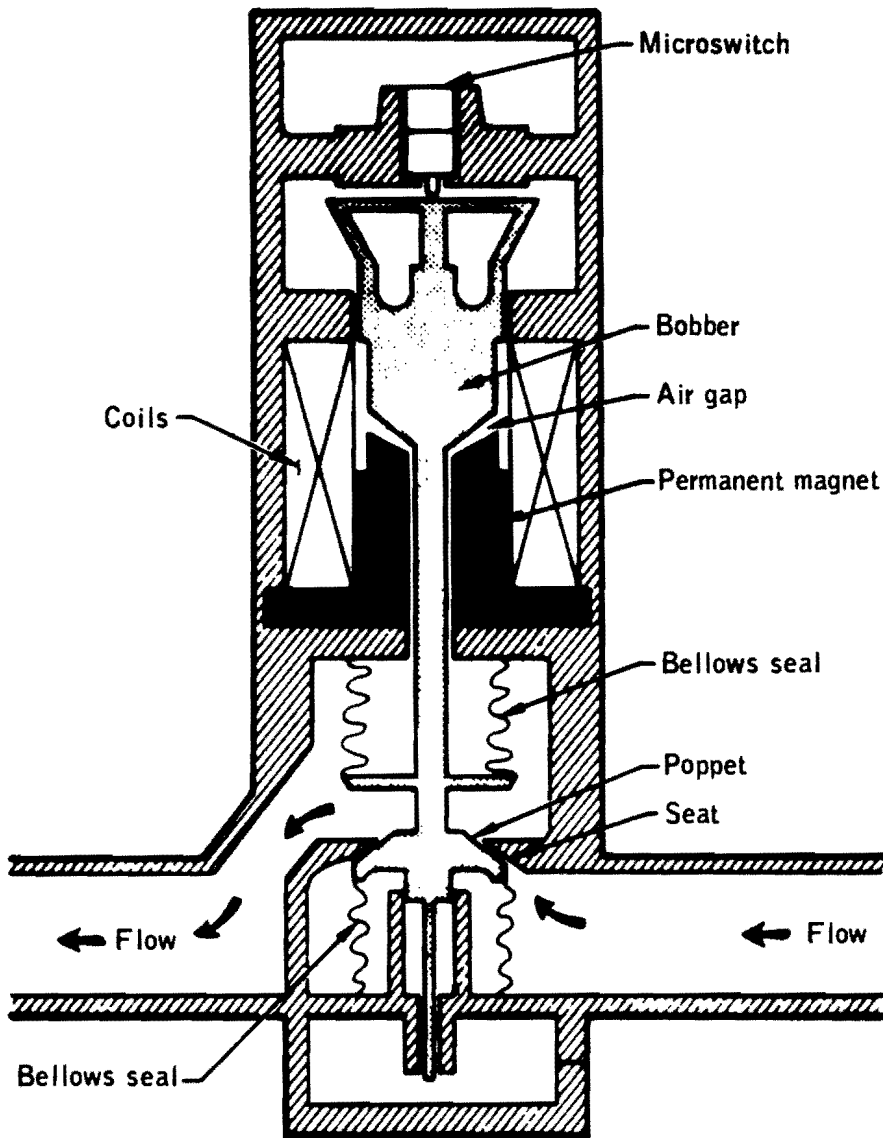
During acceptance testing of one valve for command and service module 117, the latching voltage had changed from approximately 13 volts to 3 volts. Additional testing of the spacecraft 117 valve verified the low voltage condition. Additionally, the valve stroke was proper, thereby eliminating contamination as a possible cause of the problem. During the test, the valve was disconnected from spacecraft power (28 volts) and was being supplied power through a variable power supply (approximately 20 volts, maximum, applied to the valve). The valve was most likely subjected to a reversed

Figure 14-1.- Cross section of reaction control system isolation valve.

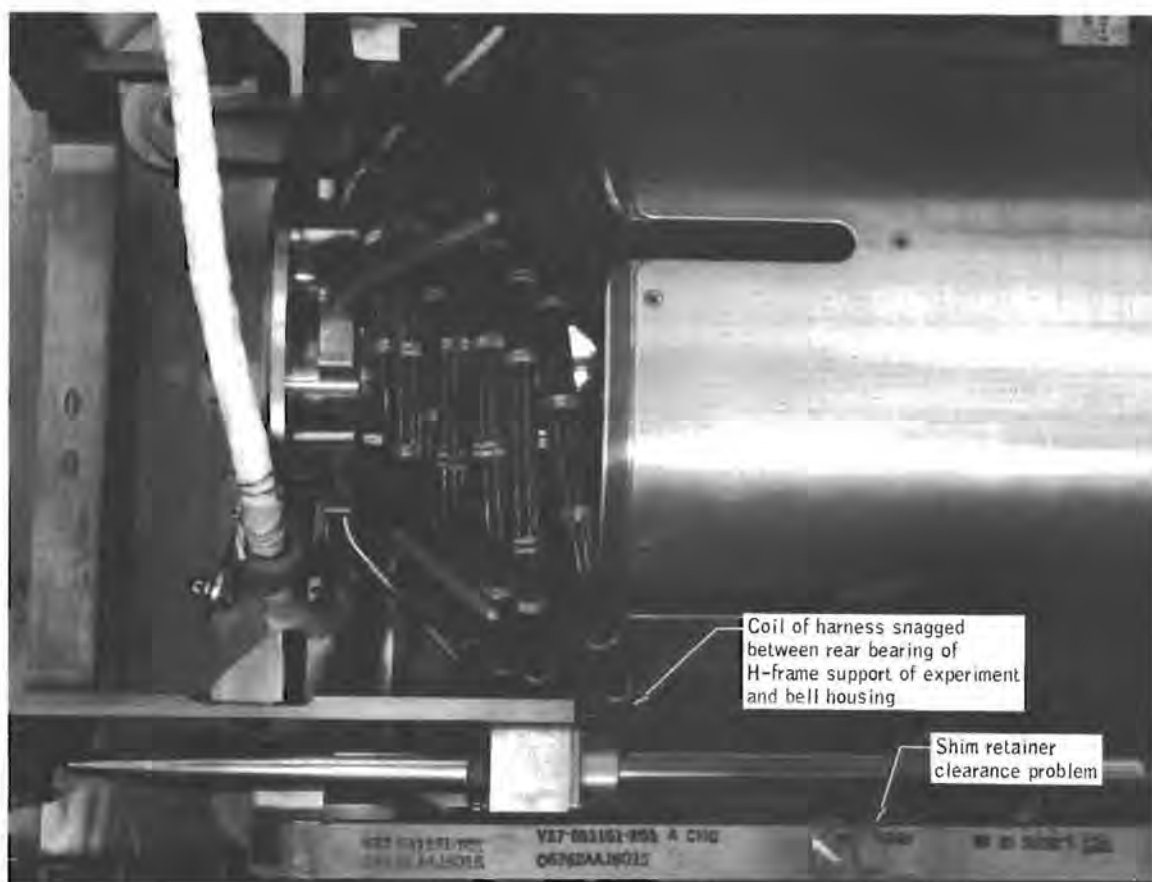
An inflight test of the Apollo 15 boom indicated that the problem was a function of temperature. Testing and examination of the Apollo 16 spacecraft showed that the failure was possibly caused by pinching of the cable harness during the last several inches of boom retraction. The cable could have been pinched between the bell housing and rear H-frame bearing (figure 14-7), or a cable harness loop was jammed by a boom alignment finger against the bell housing (fig. 14-8).

Figure 14-7.- Bottom view of mass spectrometer deployment mechanism (experiment removed).

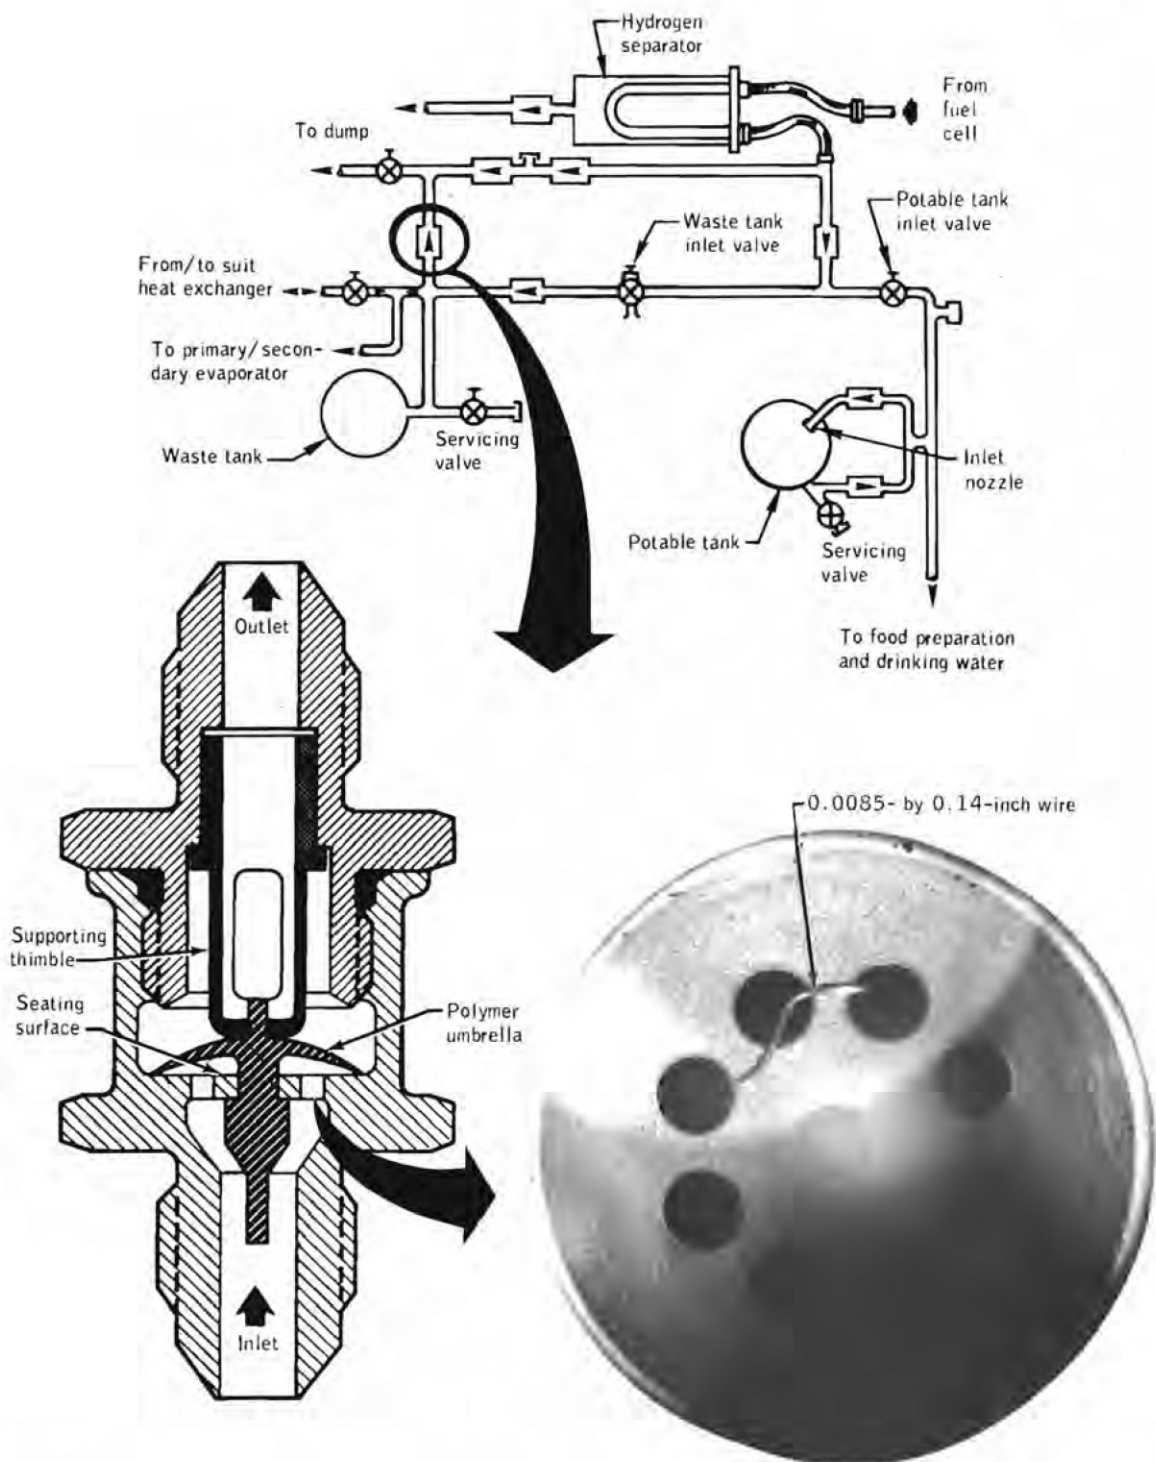
Figure 14-9.- Water management system and failed check valve details.

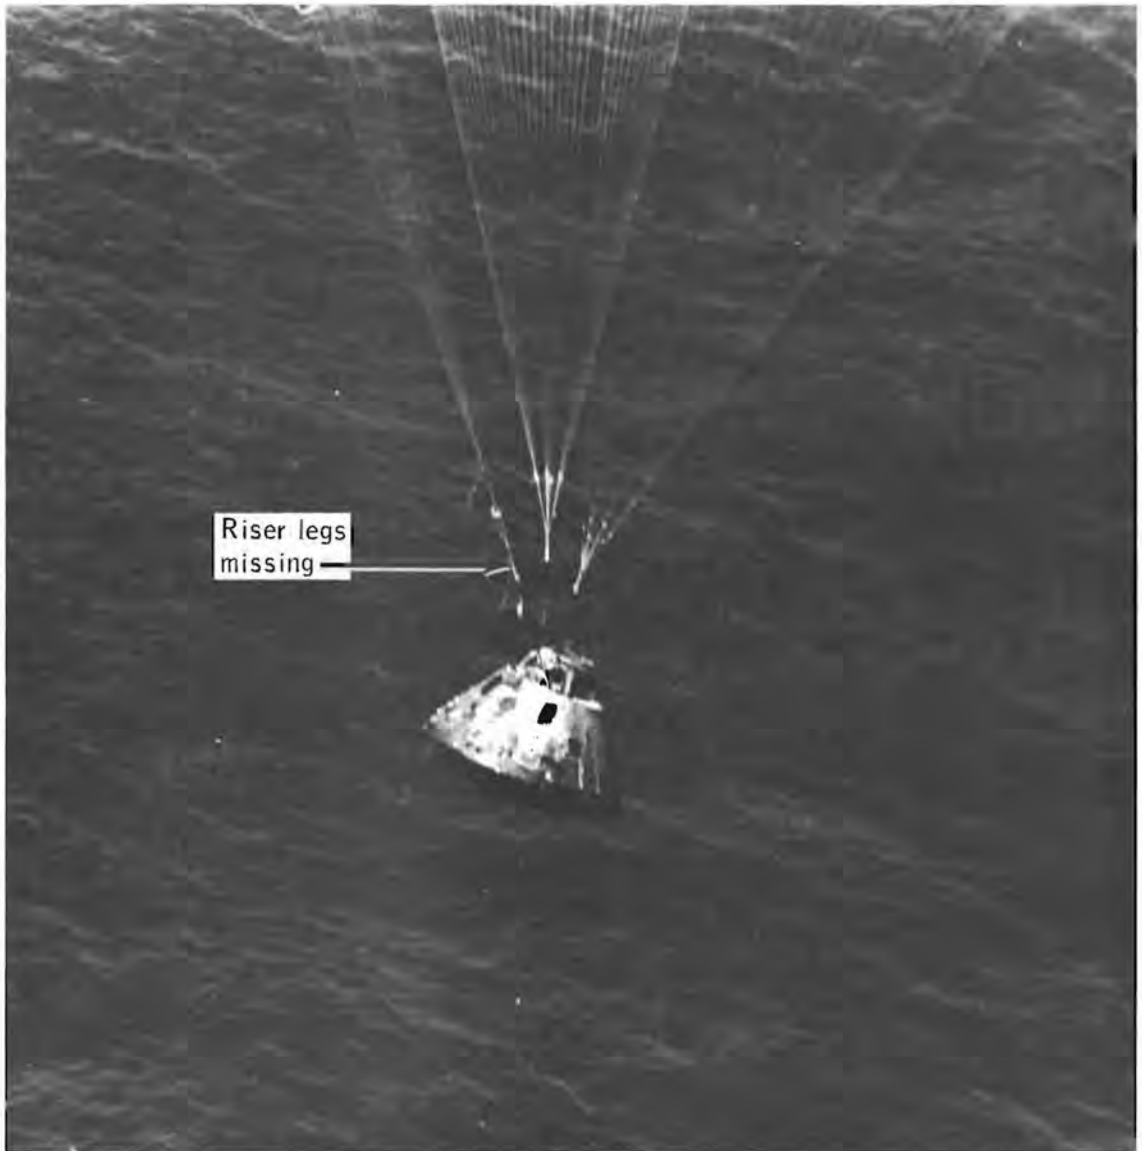
Figure 14-11.- Parachute riser damage noted during final descent.

Based on the low probability of contact and the minimum damage anticipated should contact occur, no corrective action will be implemented for the forward heat shield. Corrective actions for the reaction control system include landing with the propellants onboard for a normal landing, and biasing the propellant load to provide a slight excess of oxidizer. Thus, for the low-altitude abort land landing case, burning the propellants while on the parachutes will subject the parachutes to some acceptable oxidizer damage but will eliminate the dangerous burning fuel condition. In addition,

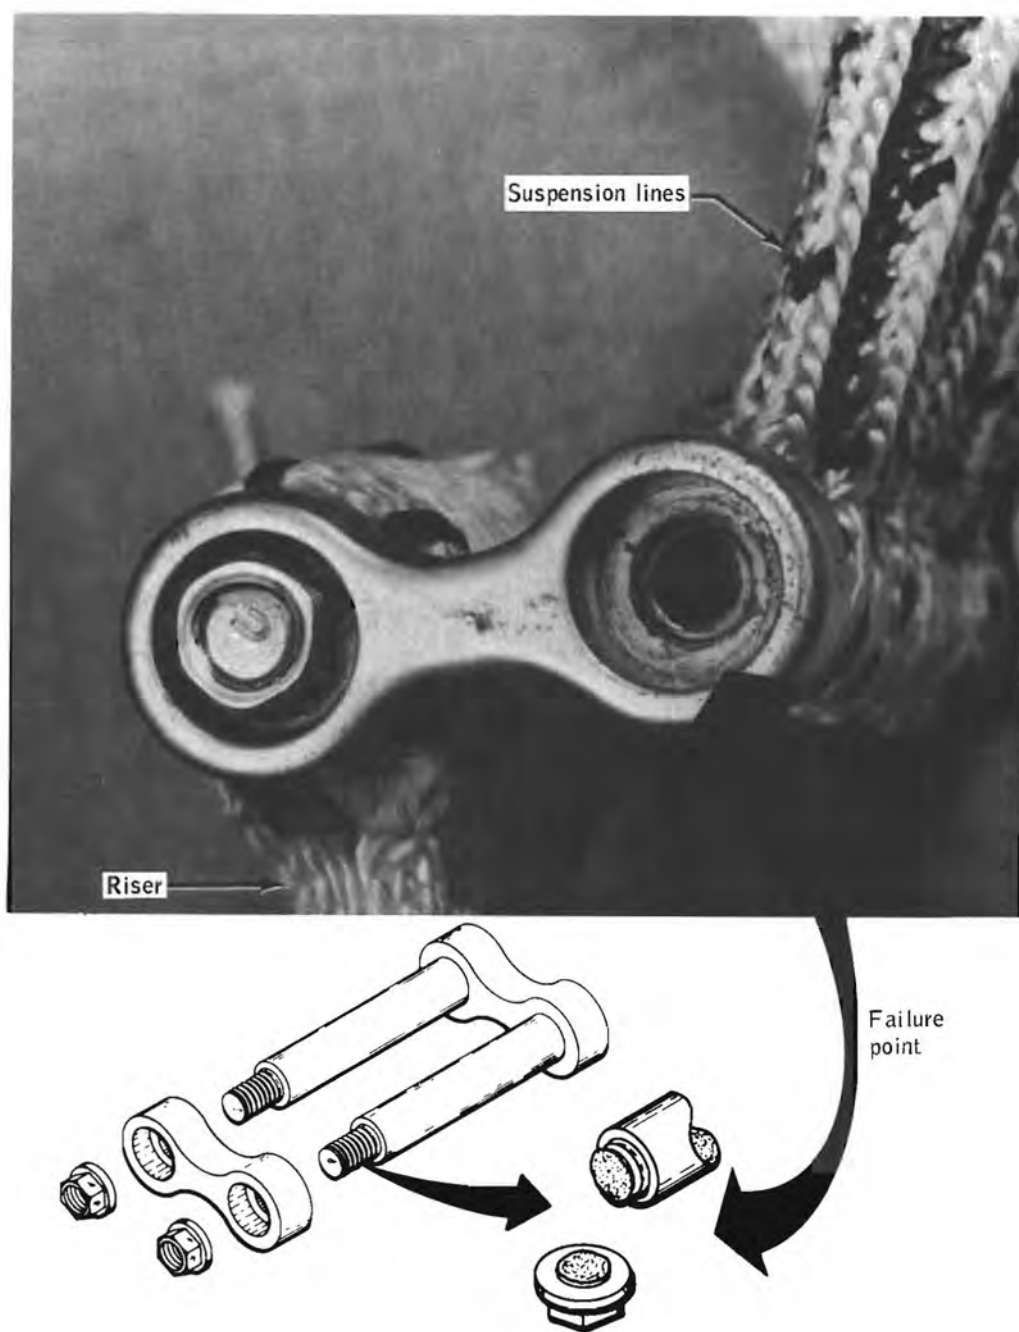
Figure 14-12.- Main parachute connector link failure.

In order to eliminate critical processing operations from manufacture of the connector links, the material was changed from 4130 to Inconel 718.

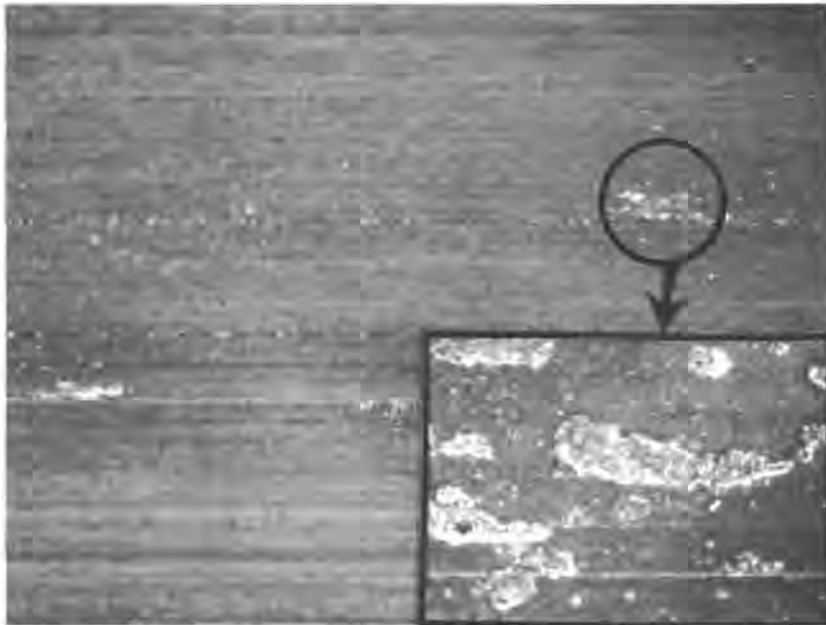
A 10-foot leader coated with a silver oxide compound is spliced to the beginning and end of the magnetic tape roll to activate the end-of-reel sensors on the tape transport. There has been a history of this material flaking off and affecting tape performance. Tape screening procedures were implemented by the manufacturer in 1968 to eliminate this problem. No further problems were encountered until Apollo 15. The recording method for Apollo 14 and previous missions was considerably different than that for the Apollo 15 mission. Bit packing densities for the Apollo 15 mission tape approach 9000 bits per inch while those for the previous missions were only 800 bits per inch. Abnormalities in the tape would have considerably more effect with the higher packing density. The utilization of the Apollo 15 mission recorder is also considerably higher, allowing more time for deposits to build up.

Figure 14-14.- Recording tape photographed under 50 power and 400 power magnification showing silver oxide deposits.

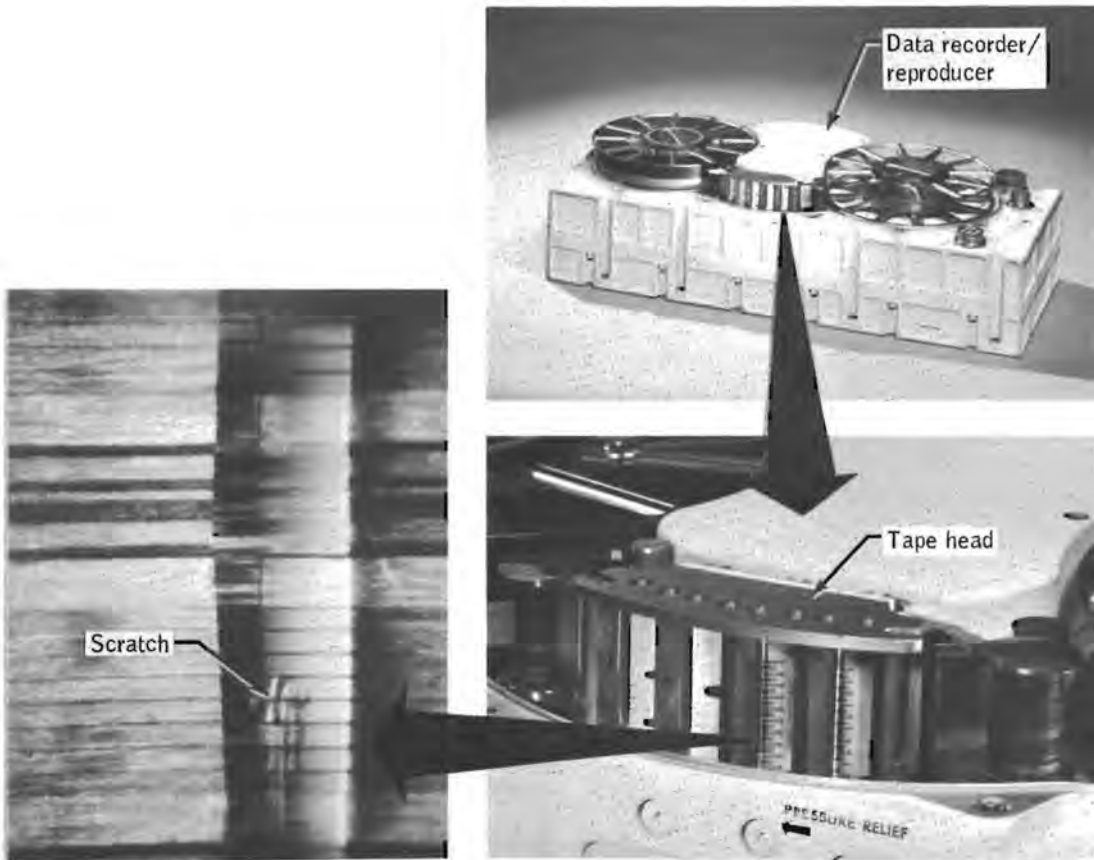
Figure 14-15.- Data recorder/reproducer and scratches on head.

Removable head covers have been provided to protect the heads from handling damage when the recorder covers are not installed. These covers have been used since early in the buildup cycle of the Apollo 16 and 17

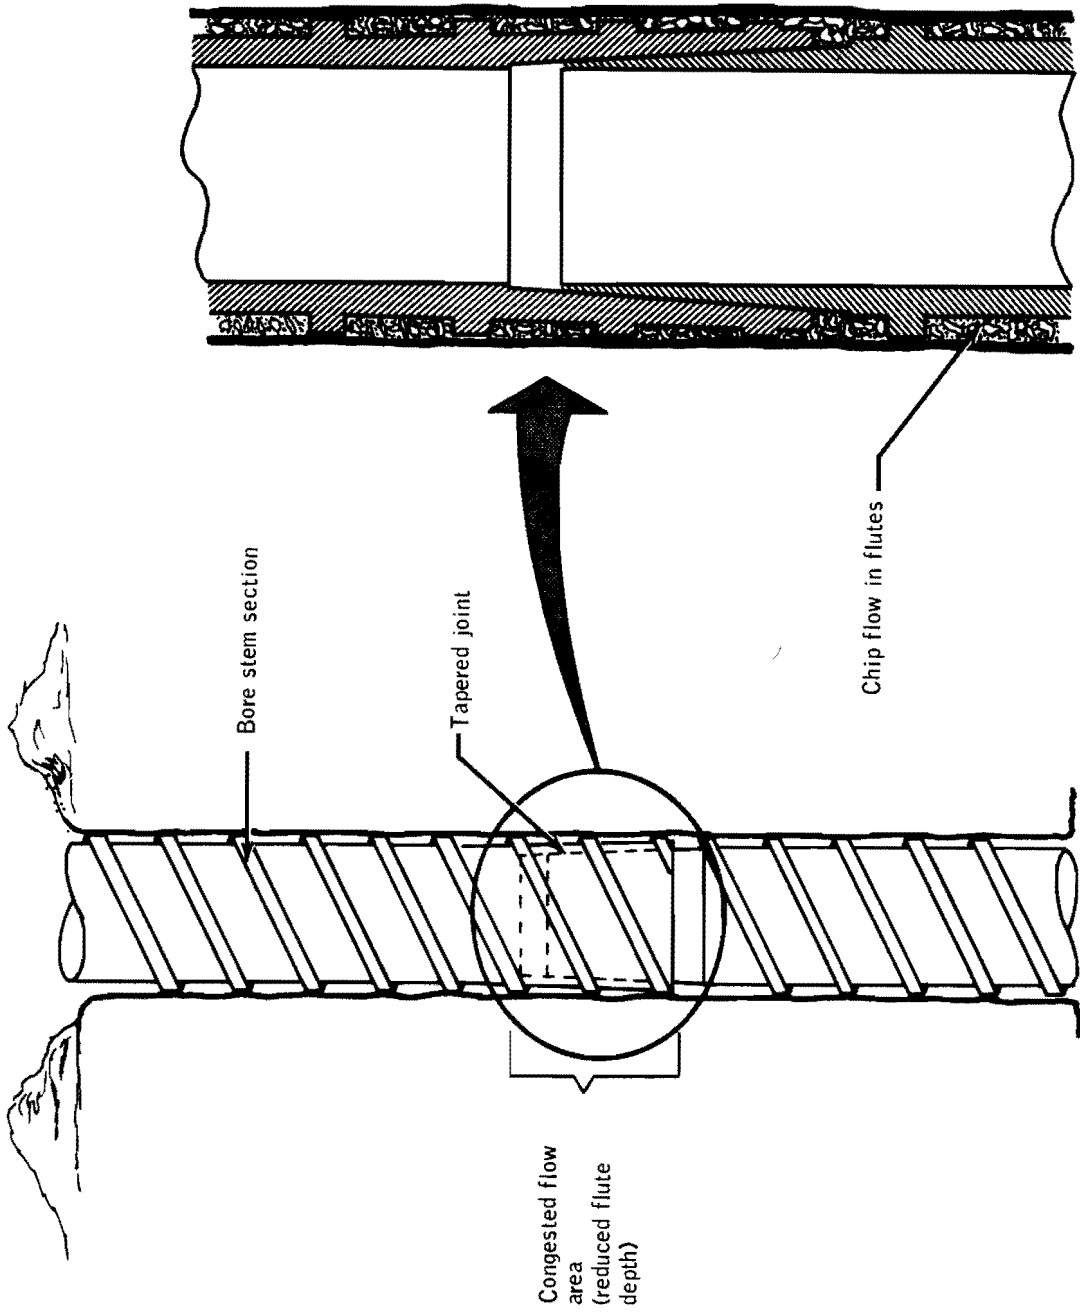
Figure 14-41.- Congestion at bore stem joints.

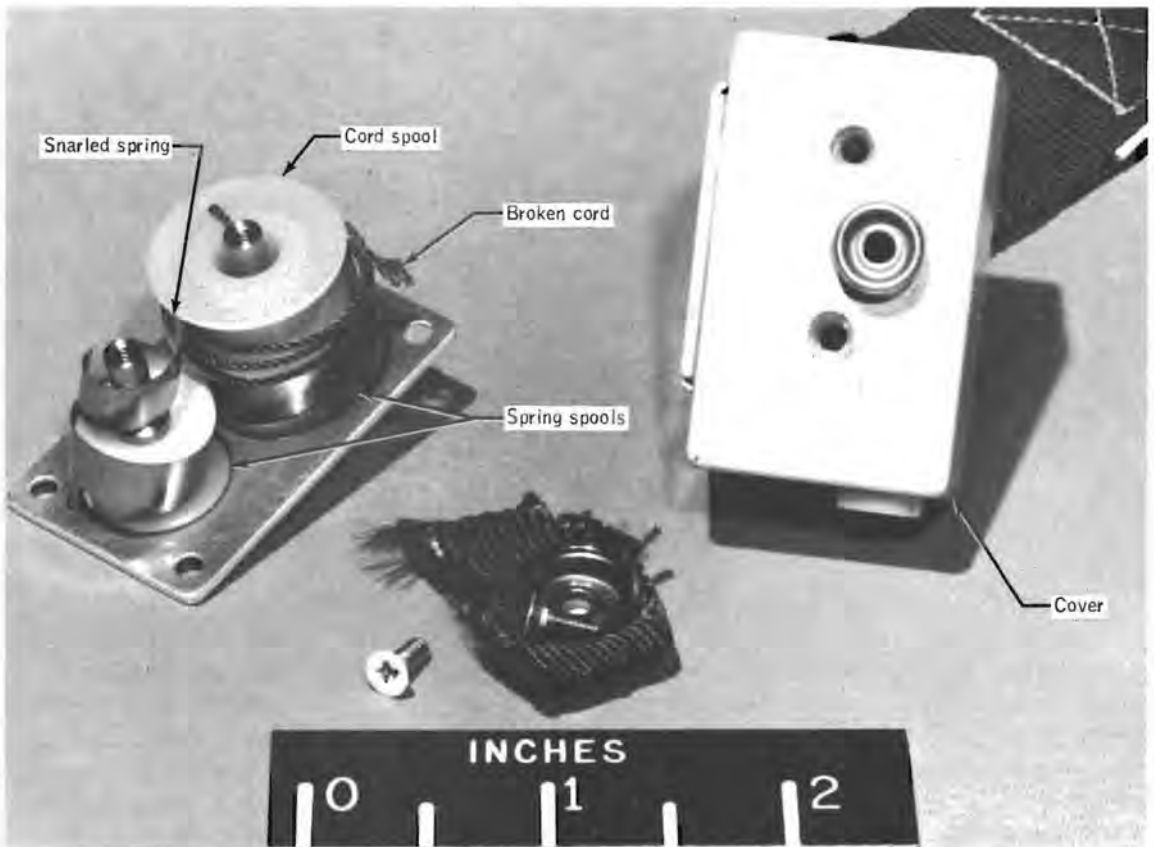
Figure 14-52.- Commander's tether (cover removed).

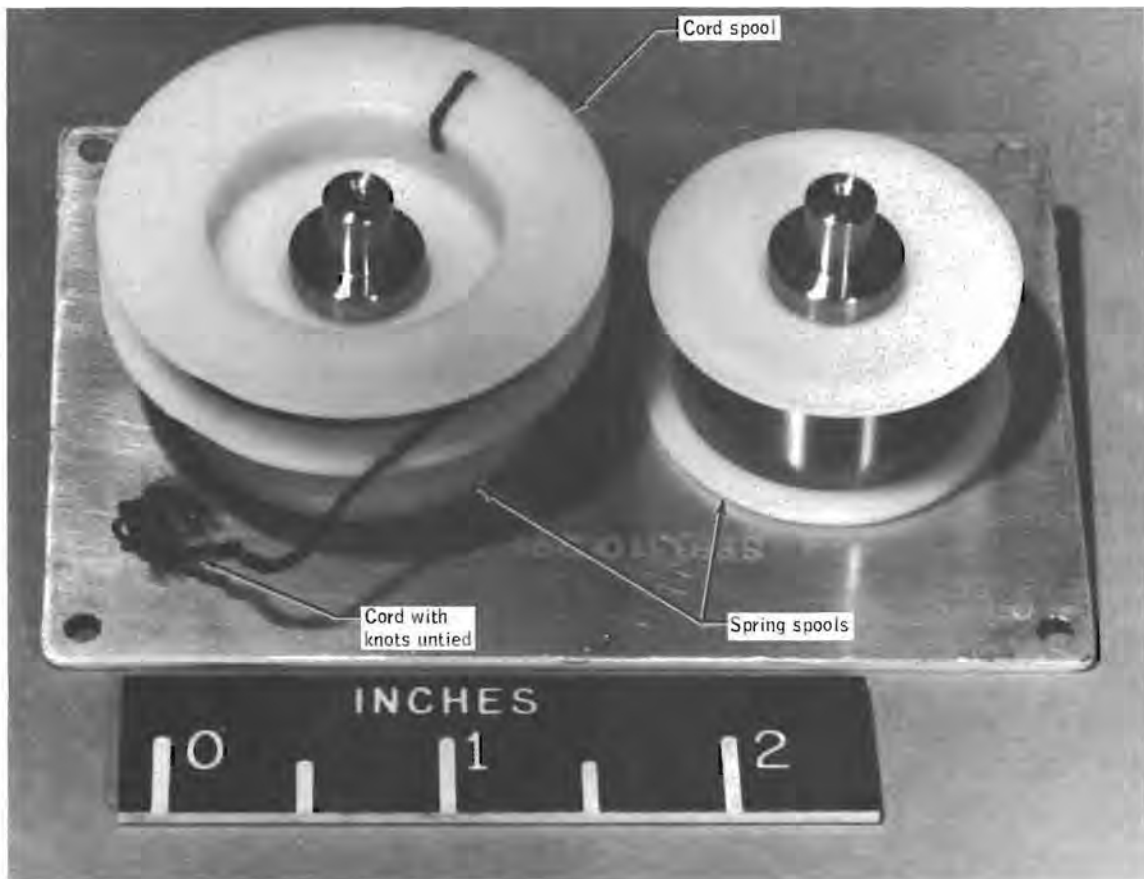
Figure 14-53.- Lunar Module Pilot's retractable tether (cover removed).
