Sol 47 TEGA Safe Mode

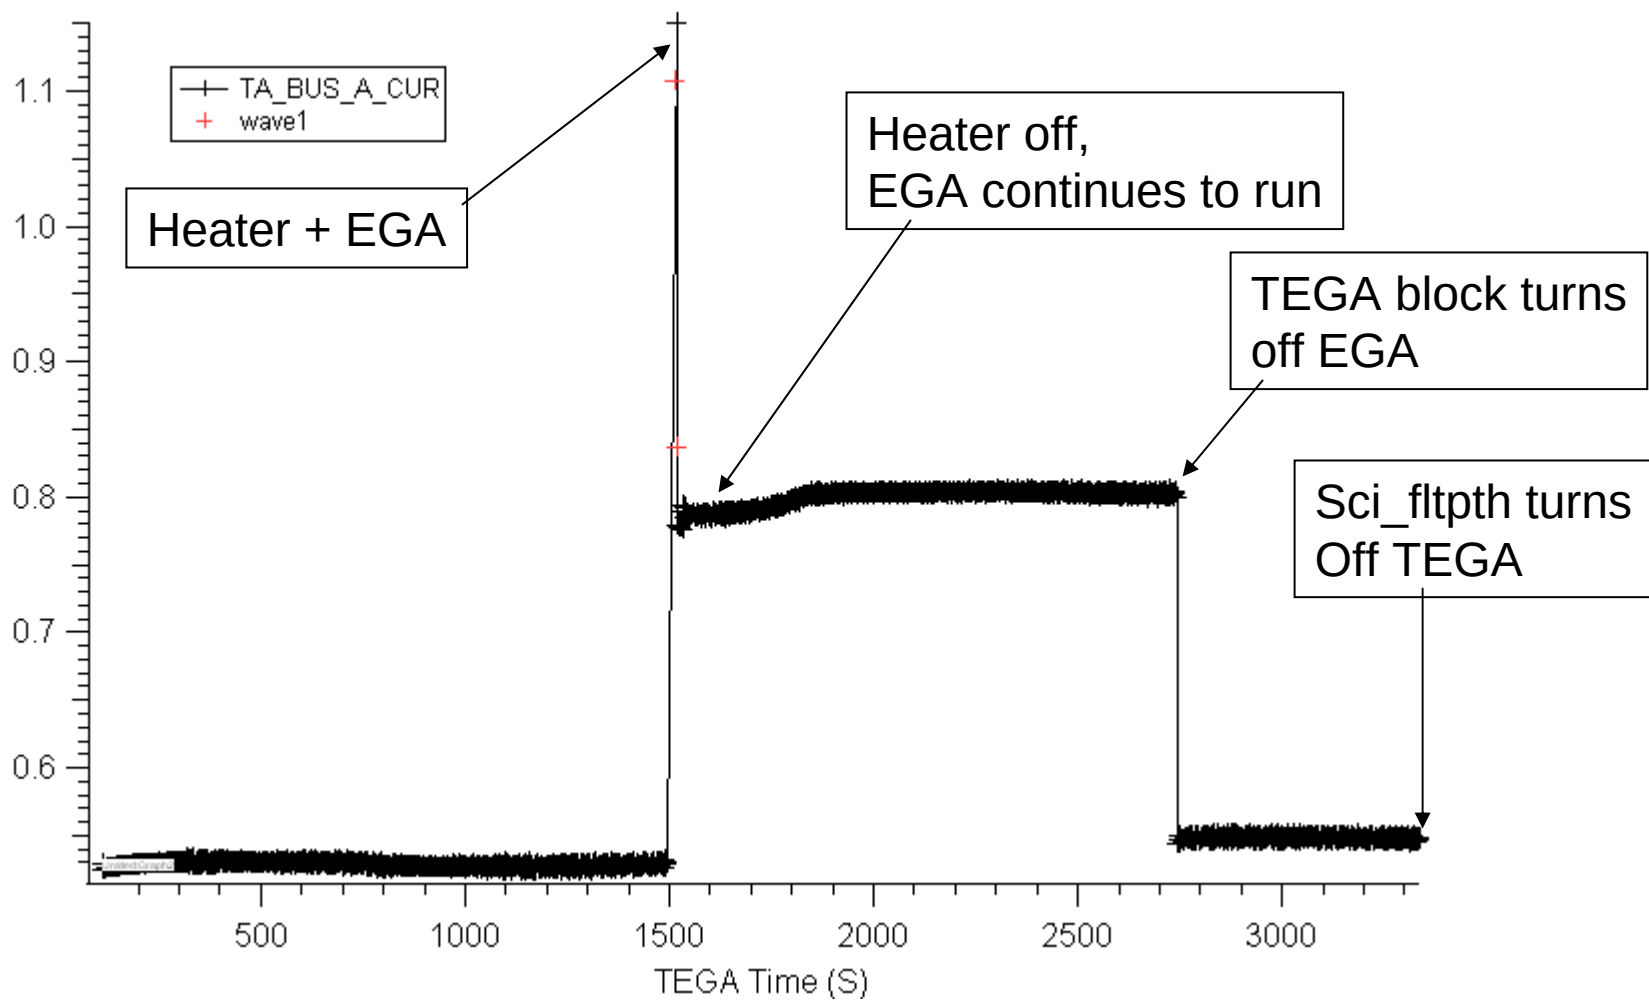
# Corrupt Engineering Packet

- TEFSW does not check packet checksum
- Packet flagged with a checksum error on the ground
- Inspection of packet shows a normal 514 byte engineering packet, BUT
- The last 6 bytes were replaced by the VML\_SET packet containing the GV\_TEGA\_EGA\_ABOVE\_MIN\_OP\_TEMP = 1 global variable command
