APOLLO 14 MISSION REPORT

MANNED SPACECRAFT CENTER

MAY 1971

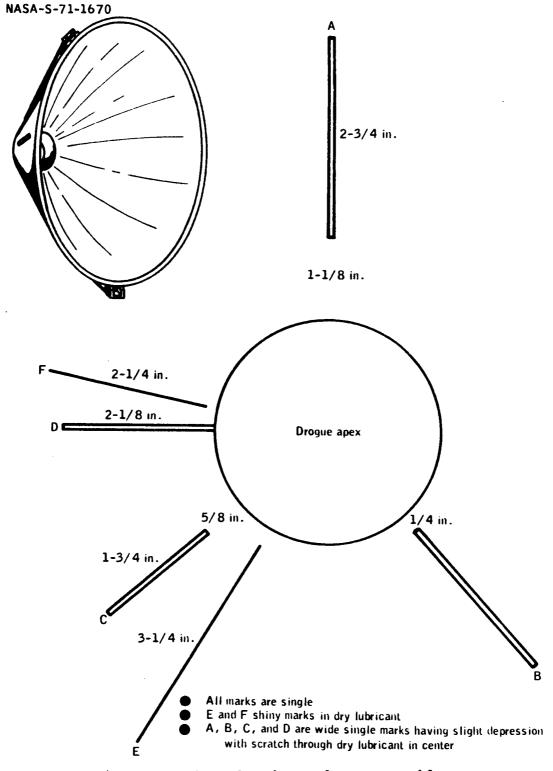
Figure 14-2.- Location of marks on drogue assembly.

b. Each of the six marks on the drogue resulted from separate contacts by the probe head (fig. 14-2). Although three of the marks are approximately 120 degrees apart, a docking impact with locked capture latches should result in three double marks (to match the latch hooks) 120 degrees apart, and within one inch of the drogue apex or socket. Although the drogue marks could indicate that the individual capturelatch hooks were difficult to depress, such marks are not abnormal for impact velocities greater than 0.25 feet per second.

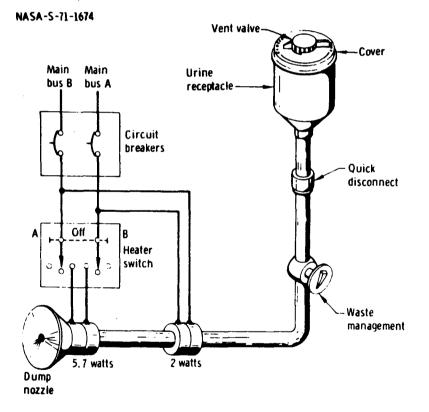
Figure 14-6.- Urine receptacle and nozzle.

After transposition and docking and prior to initiating passive thermal control, the crew indicated that the urine nozzle (fig. 14-6)

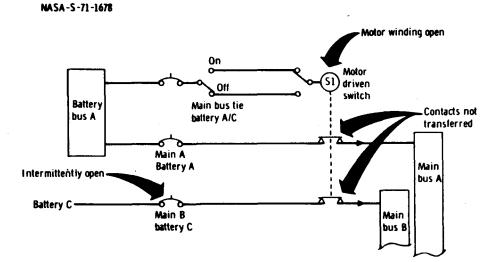
Figure 14-10.- Bus-tie circuitry.

During entry, when the main bus tie switches (motor-driven switches) were placed in the off position at 800 feet, main bus A should have deenergized; however, the bus remained on until after landing when the battery bus-tie circuit breakers were opened. Postflight testing showed that the main motor switch contacts were closed (fig. 14-10). Also, the

The motor switch failure discussed in section 14.1.6 should have resulted in main buses A and B being energized after the motor switch was commanded open (fig. 14-10). Postflight continuity checks, however, showed that there was an open circuit between battery C and main bus B and that the main bus B circuit breaker for battery C was intermittent.

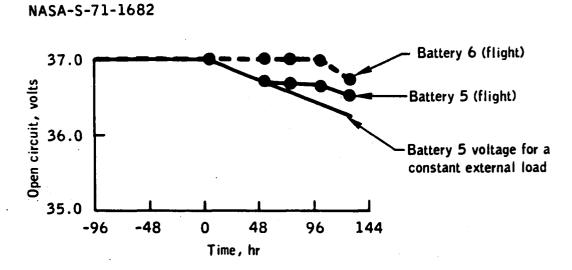
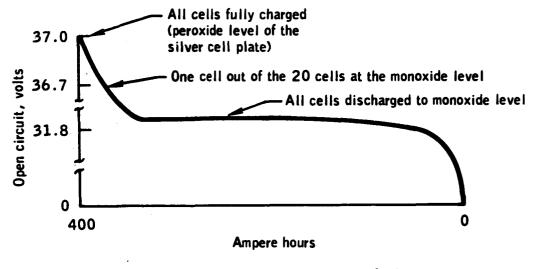
Figure 14-14.- Ascent battery voltage characteristics.

At 62 hours, the ascent battery 5 open-circuit voltage had decreased from a lift-off value of 37.0 volts to 36.7 volts instead of remaining at a constant level (fig. 14-14(a)). Figure 14-14(b) shows characteristic open-circuit voltages for a fully charged battery (peroxide level of all cells) and all cells operating on the monoxide level of the silver plate. Note that one cell at the monoxide level and the remaining 19 at the peroxide level would have caused the observed open-circuit voltage of 36.7 volts. Any one of the following conditions could have caused the voltage drop.

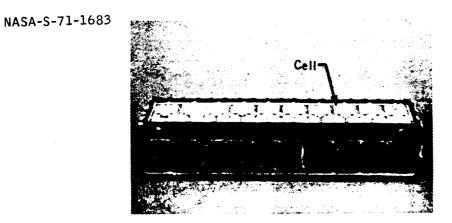
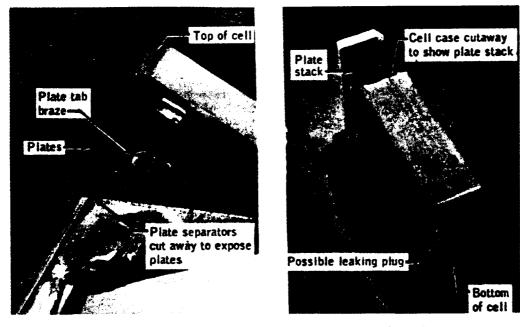
Figure 14-15.- Ascent battery cell structure.

A single-cell short could be caused by inclusion of conductive foreign material in the cell-plate pack at the time of manufacture or excessive braze material at the brazed joint between the plate tab and plate grid, either of which could pierce the cellophane plate separator during the launch powered-flight phase, providing a conductive path between positive and negative plates (fig. 14-15).

During battery activation, one of the descent batteries had a cell short to the case through an electrolyte path around a cell plug joint (fig. 14-15). The cell plug was not properly sealed to the bottom of the plastic cell case. If this condition existed in ascent battery 5 in flight, it could have decreased the battery open-circuit voltage.

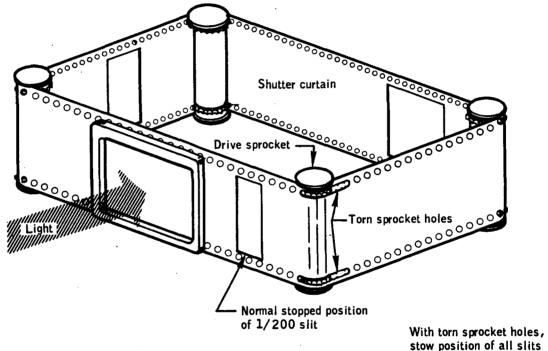
Figure 14-28.- Lunar topographic camera film track.

loose piece of aluminum 0.130 inch by 0.008 inch, which was foreign to the transistor material. With a shorted transistor, 28 volts is applied continuously to the shutter drive circuit, causing continuous shutter operation, independent of the intervalometer and independent of the single, auto, or standby mode selections. The sprocket holes in the 1/200 slot in the shutter curtain were torn as a result of the prolonged, continuous, high-speed shutter operation (fig. 14-28).

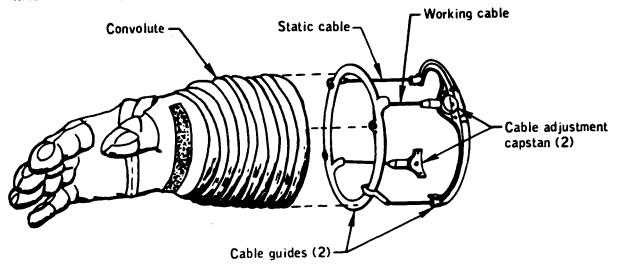
Figure 14-29.- Extravehicular glove wrist control.

After suit pressurization for the second extravehicular activity, the Lunar Module Pilot reported that his right glove had pulled his hand to the left and down and that he had not had this trouble during the first extravehicular activity period. The condition was a nuisance throughout the second extravehicular activity period. Initial indications from the Lunar Module Pilot were that a cable had broken in the glove (fig. 14-29).

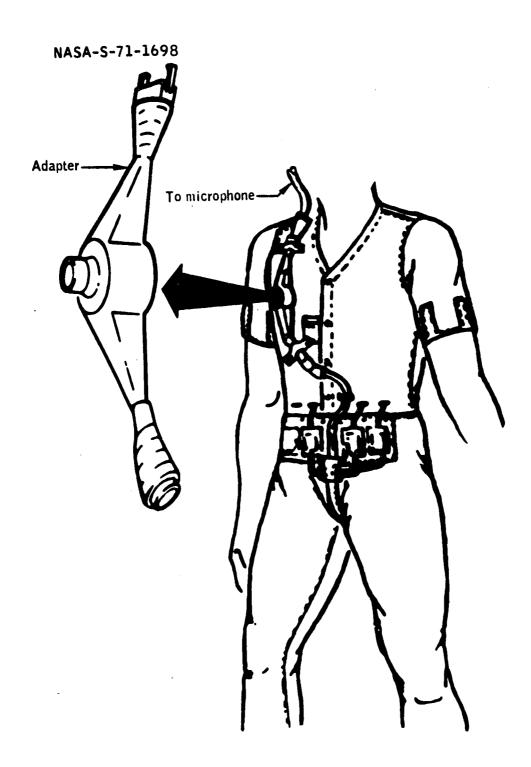
Figure 14-30.- Constant wear garment communications harness.

At approximately 29 hours, Mission Control had difficulty in communicating with the Commander. The Commander replaced his constant wear garment electrical adapter (fig. 14-30) with a spare unit, and satisfactory communications were reestablished.

Following release of the hardware from quarantine, all four constant wear garment electrical adapters were tested for continuity and resistance, and all units were satisfactory. The adapters were then

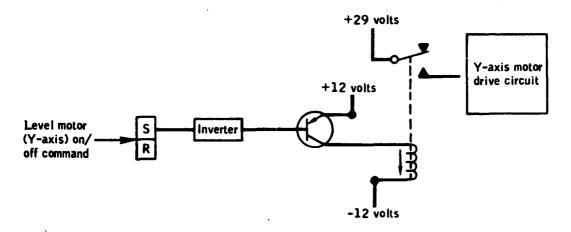
Figure 14-33.- Y-axis leveling motor circuitry.

The horizontal Y-axis leveling motor of the ginbal leveling system operates intermittently (fig. 14-33). Although a command verification is received when commands are sent, power is not necessarily received by the motor. When there is an indication of power to the motor, the motor does operate. As a result, during the first lunar day, response to ground commands was normal except for 6 of the 22 commands when there was no response.

Although no scientific data have been lost to date, intermittent problems have been encountered when leveling the Y-axis of the gimbal platform upon which are mounted the three orthogonal long-period seismometers. Occasionally, either there is no electro-mechanical response, or the response is delayed when the Y-axis motor is commanded on. Delay times vary. Thus far, leveling has been achieved by cycling on/off commands at varying time intervals.

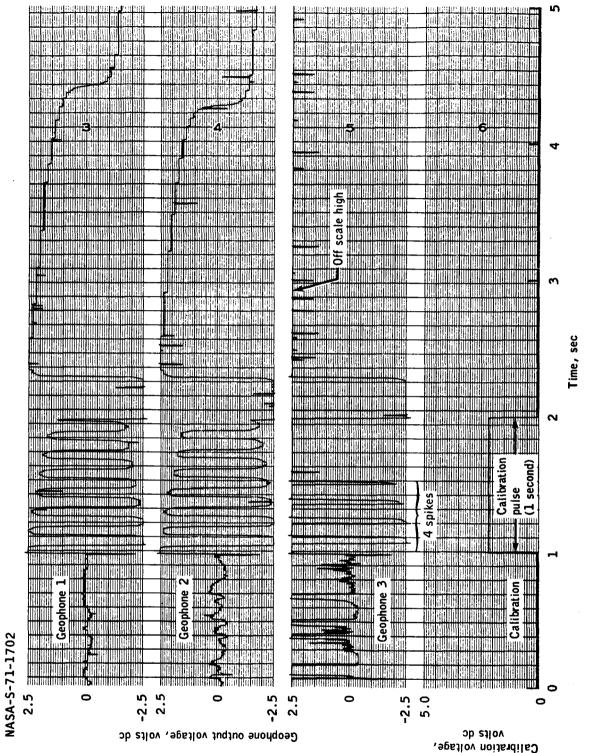
The experiment was turned on in the listening mode on March 26, 1971, and geophone 3 data were spiking off-scale high (fig. 14-34). When the geophone channels were calibrated, the geophone 3 channel went off-scale high simultaneously with the start of the calibration pulse and stayed off-scale high for the remainder of the listening period. During the 1-second period when the calibration pulse was present, data from geophones 1 and 2 showed the normal 7-hertz ringing caused by the calibration pulse. However, geophone 3 data showed four negative-going spikes coincident with the first four negative half cycles of the ringing on the other two channels. The spikes decreased in duration from the first to the last, the last having an amplitude of 90 percent of

Figure 14-34.- Geophone calibration data.

full scale (plus 2.5 volts to minus 2.0 volts). During the time that this pulse was present, the signal on channel 2 changed from minus 2.2 volts to minus 2.35 volts, indicating that channel 3 was operating at an apparent gain of 30 times the channel 2 gain.

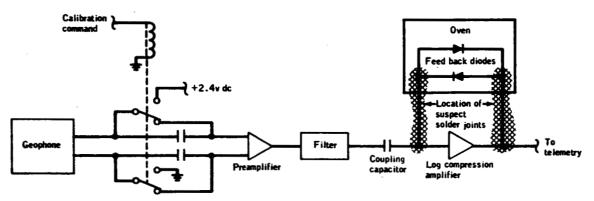
NASA-S-71-1703

As shown in figure 14-35, each geophone channel consists of a geophone, an input preamplifier, a low-pass filter, and a logarithmic compressor amplifier. The output of the logarithmic compressor feeds the instrumentation system. The logarithmic compressor is basically an inverting amplifier with exponential negative feedback. Two diode-connected transistors between the output and input of the amplifier supply the feedback. The first diode is used for positive-going and the second for negative-going input signals. The diodes for all three geophone channels (two per channel) are physically located in an oven which controls their temperature at 105° C.

Figure 14-35.- Typical geophone channel.

It is believed that the failure is in the logarithmic compression amplifier because signals are coupled into it through an input coupling capacitor. This capacitor would block any offset voltages from the preceding stages which would be required to drive the output off-scale high. Analysis indicates that the most probable cause of the problem is an intermittent open circuit in the diode feedback path. This would allow the amplifier input transistor to saturate, driving the output off-scale high. When signals large enough to drive the input stage out of saturation were present, the output would then respond and the output signal would not be compressed. The experiment electronics uses "cordwood" construction of the type which has caused solder cracks in other equipment. Two copper paths conduct the feedback diodes to the logarithmic compressor amplifier. A solder crack in either path would then result in the data characteristics.
