MSC-05161

APOLLO 15 MISSION REPORT

MANNED SPACECRAFT CENTER
HOUSTON, TEXAS
DECEMBER 1971

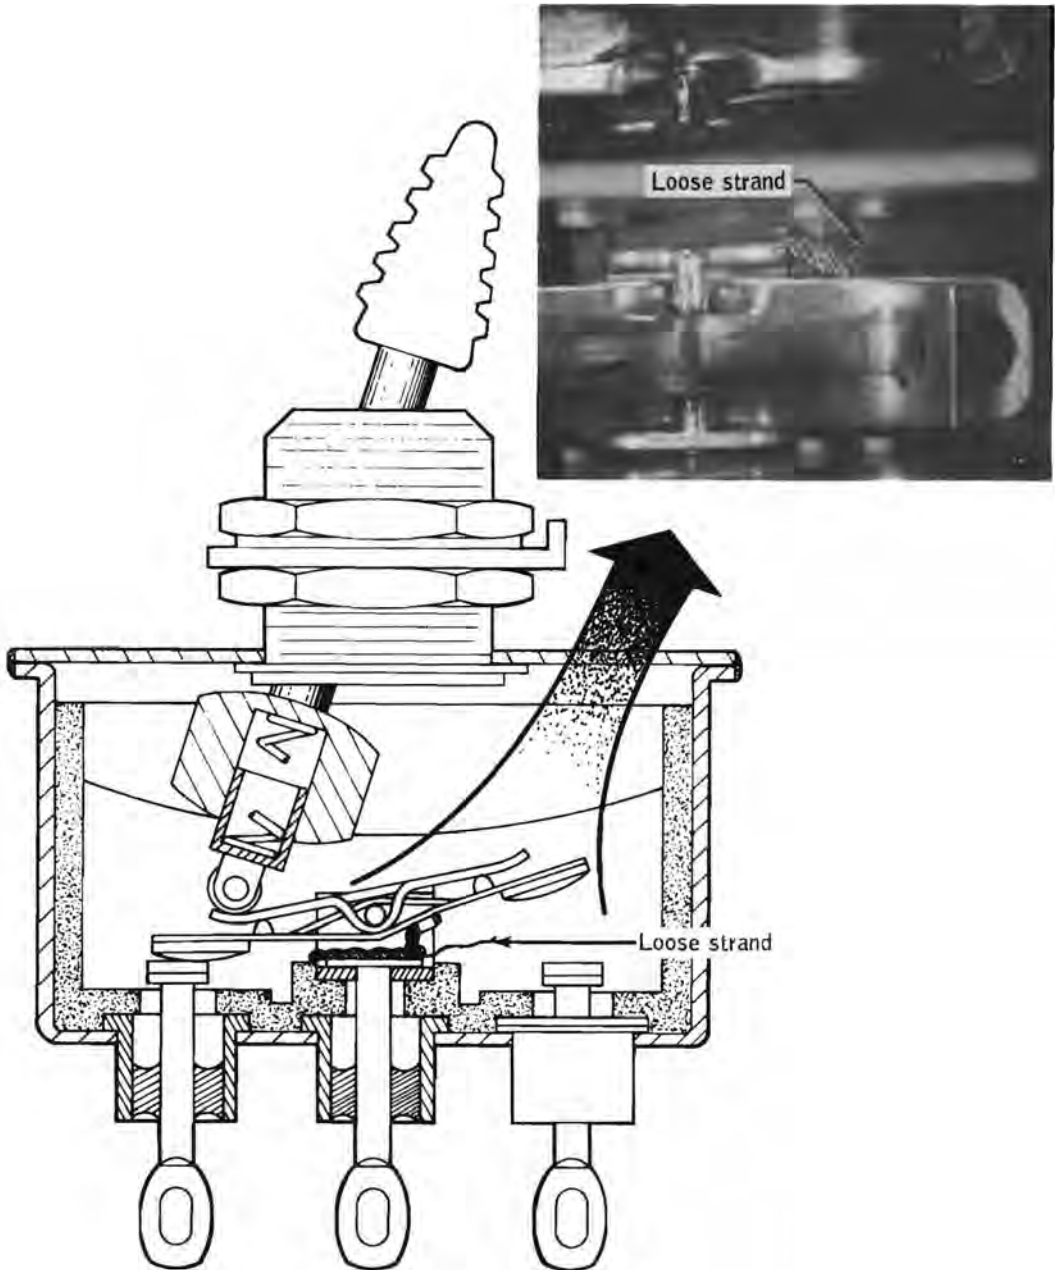
Figure 14-4.- Service propulsion system delta-V thrust switch.

The delta-V thrust switch (fig. 14-4) was shorted to ground both before and after removal of panel 1 from the command module during post-flight testing. After a change in panel position, the short-to-ground disappeared. The switch was then removed from the panel and X-rayed. The X-rays showed a wire strand extending from the braid strap which was thought to have caused the grounding problem. After switch dissection, an internal inspection verified that a strand extended from the braid strap; however, it did not appear to be long enough to cause a ground at any point within the switch (fig. 14-4). The bracket assemblies (pivot brackets, pigtail braids, and movable contacts) and the plastic liner were removed from the switch. Microscopic examination revealed that a wire strand (approximately 0.055 inch long) was present on the flange on terminal 2 (fig. 14-5). The strand appeared to be attached, but was later moved quite easily.

Most of the switches on Apollo 16 and 17 spacecraft (3000 or 4000 series) required for crew safety or mission success were screened according to the following procedures.

- a. Additional inspection points were employed during manufacturing.
- b. The switches were X-rayed prior to acceptance testing.

c. The acceptance vibration test was 3-axis random (4000 series) or single-axis sinusoidal (3000 series) test.

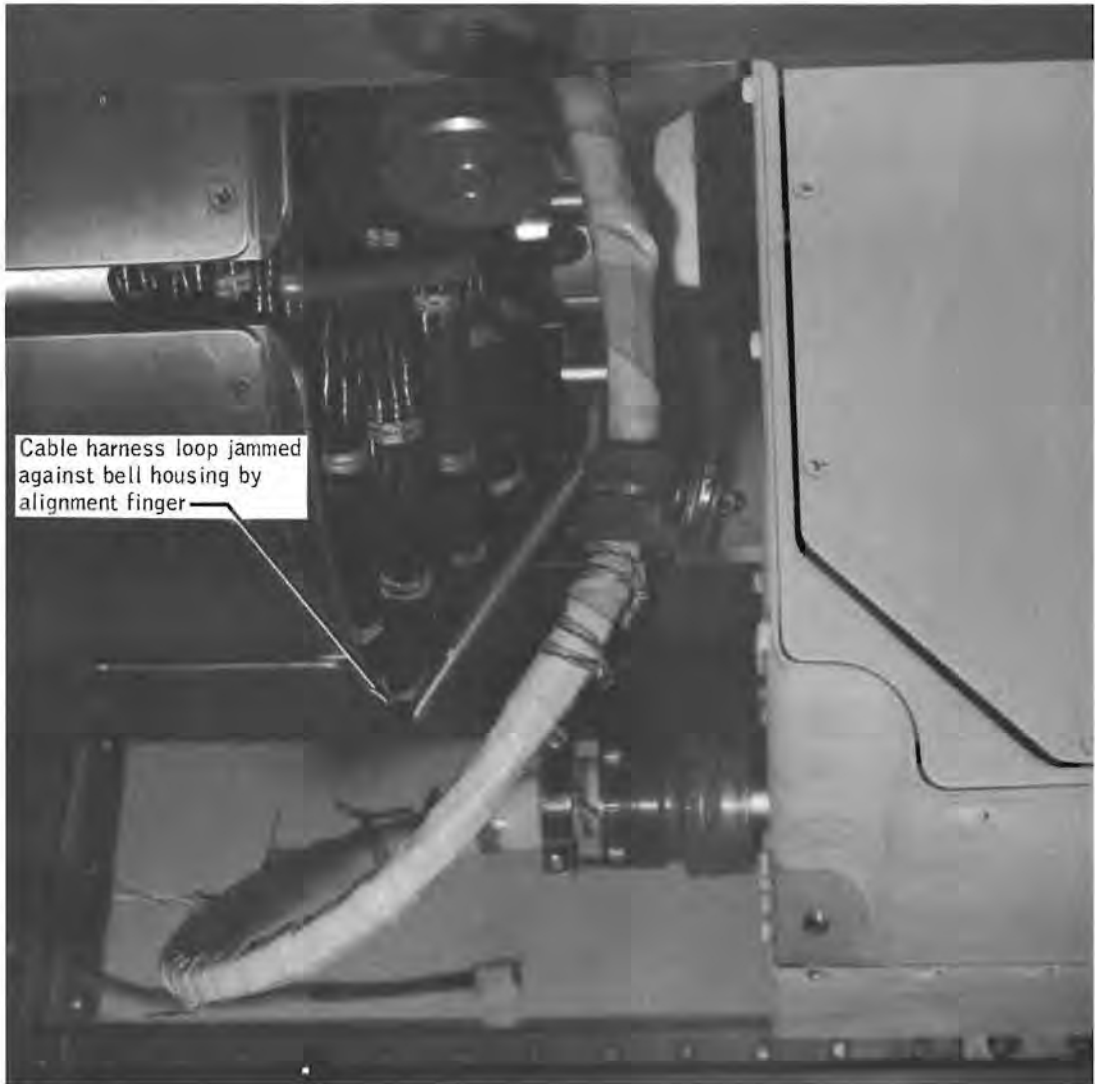
Figure 14-8.- Side view of mass spectrometer deployment mechanism (experiment attached).

An inflight test of the Apollo 15 boom indicated that the problem was a function of temperature. Testing and examination of the Apollo 16 spacecraft showed that the failure was possibly caused by pinching of the cable harness during the last several inches of boom retraction. The cable could have been pinched between the bell housing and rear H-frame bearing (figure 14-7), or a cable harness loop was jammed by a boom alignment finger against the bell housing (fig. 14-8).

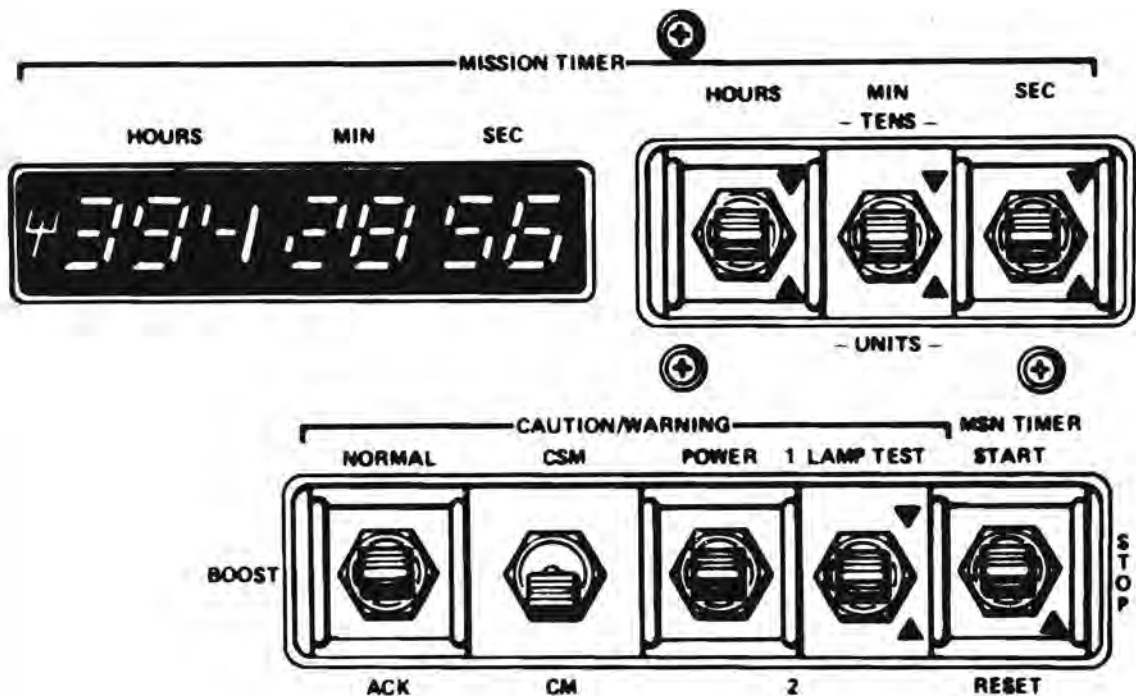
Figure 14-10.- Mission timer.

The panel 2 mission timer stopped at 124:47:37. Several attempts to start the clock by cycling the start/stop/reset switch from the stop to the start position failed (fig. 14-10). The timer was reset to 124:59:00 using the hours, minutes, and seconds switches, and the timer again failed to start when the switch was cycled. The switch was then placed in the

The timer and all associated equipment were still operating properly after the flight. Thermal, vacuum, and acceptance tests were performed and the cause of the failure could not be determined. Circuit analysis showed that the problem could be caused by one of five integrated circuits on the mounting board circuitry. These suspect components were removed and tested with negative results.

The failure was most probably caused by an intermittent problem within a component which later cured itself. If the problem occurs on a future mission and the timer will not restart, mission time can be obtained

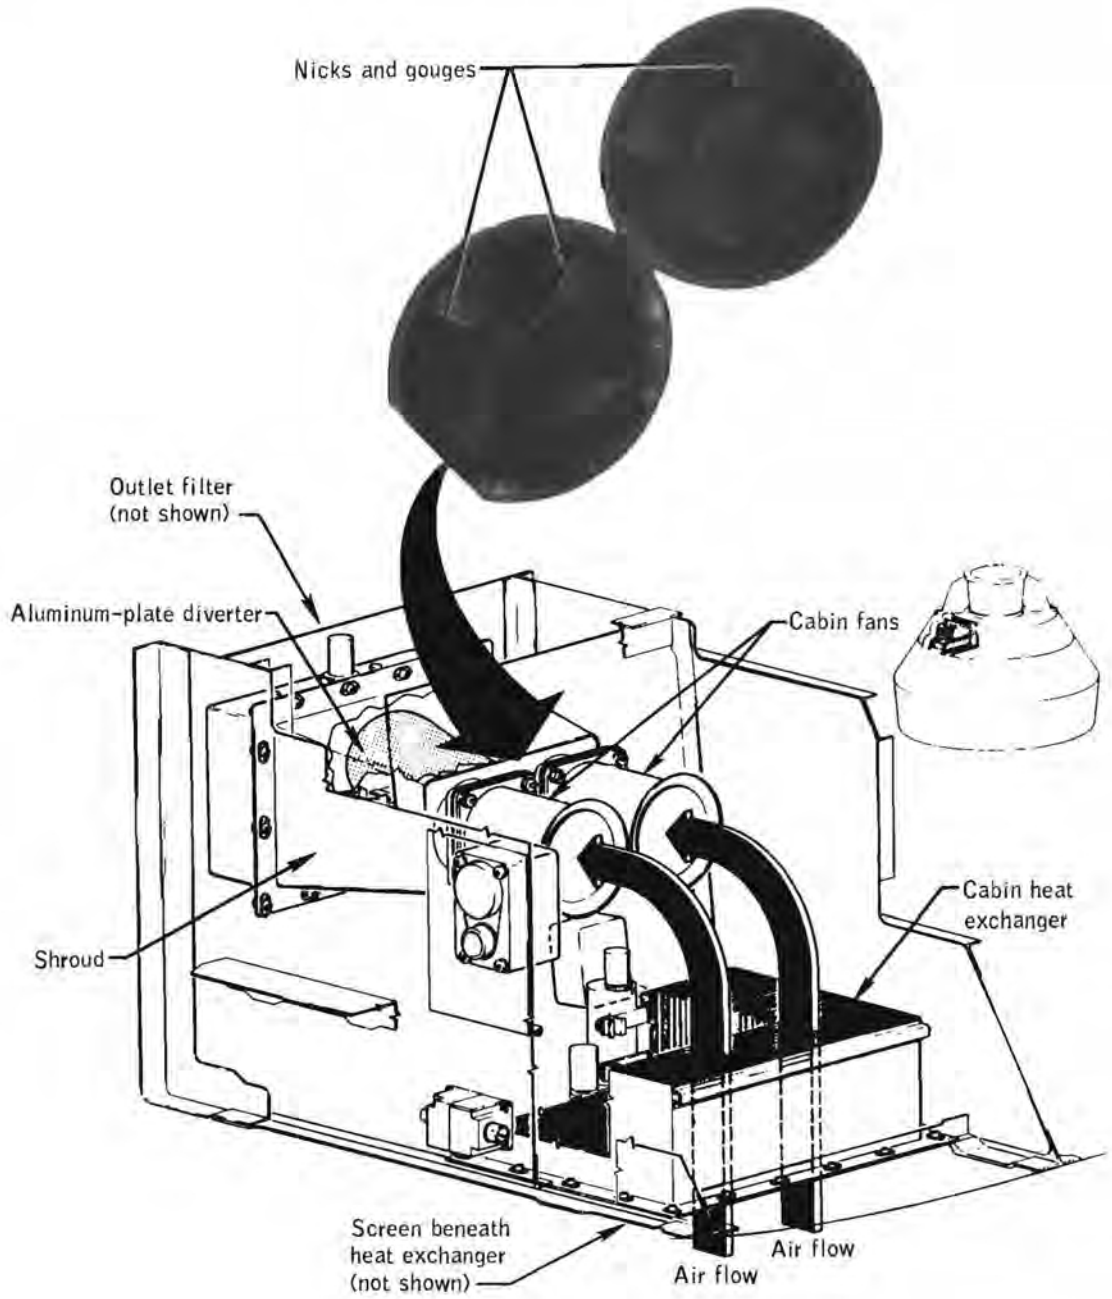
Figure 14-19.- Cabin fan installation.

During portions of the flight when the cabin fans (fig. 14-19) were activated, the crew heard sounds like an object striking the blades. Cycling the fans several times allowed the object to be retained in a position that precluded it from interfering with fan operation.

Inspection of the fans revealed considerable gouging on the leading edges of the blades of both fans (fig. 14-19). No marks were found on the outlet de-swirl vanes of either fan. After extensive examination, including the lunar dust filter, a 1/4-inch washer was found in the ducting.

drifted in and out when the fans were not operating. The outlet was protected only during the limited time when the lunar dust filter was installed. The washer could also have been left in the duct during assembly.

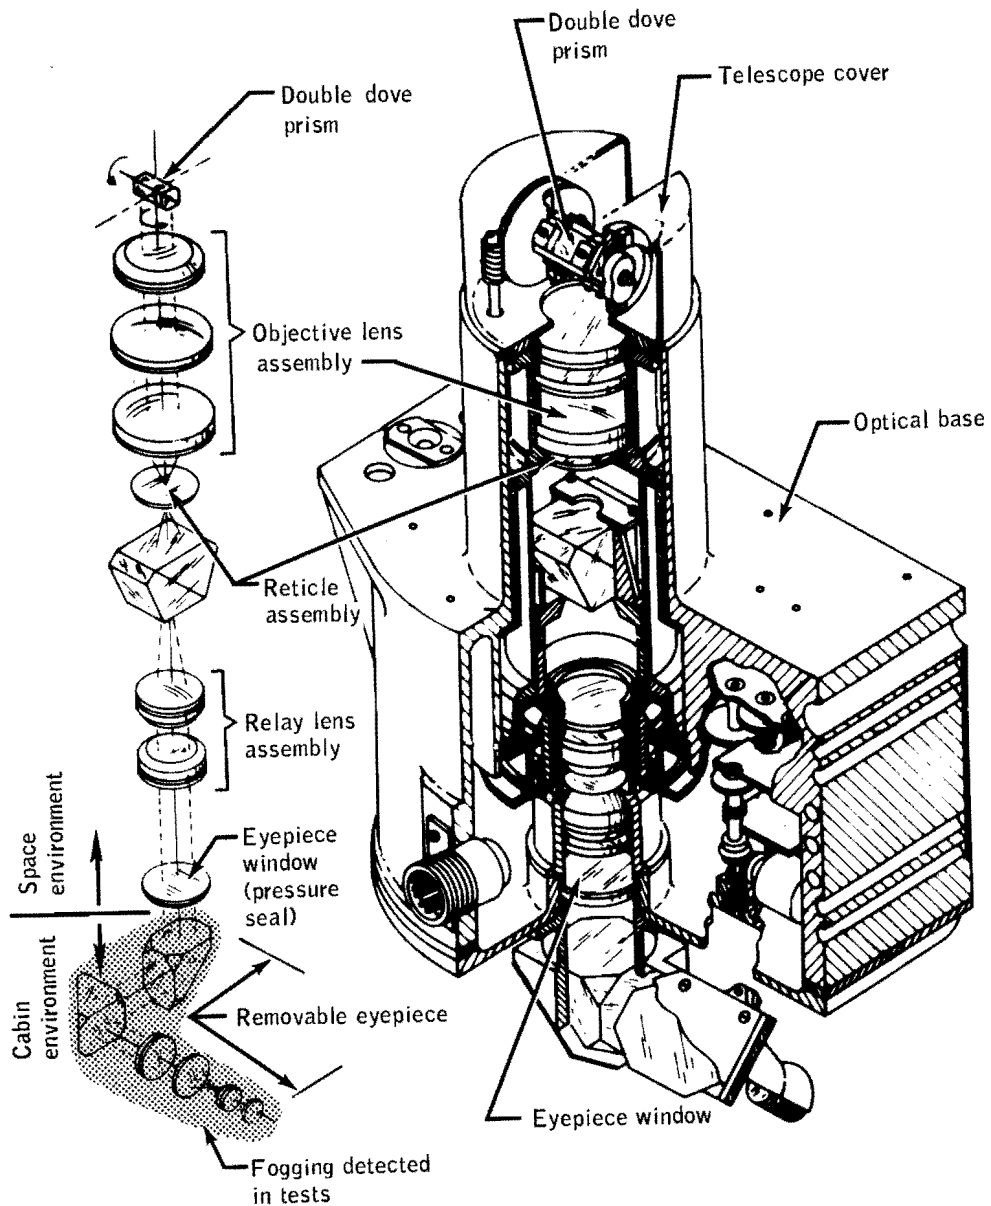
Figure 14-20.- Scanning telescope assembly.

Visual observations through the telescope (fig. 14-20) were made at the spacecraft manufacturer's facility, and no degradation could be observed. A luminescent transmittance test was performed on the telescope before removal from the spacecraft and transmittance was calculated to be 25 percent. This compares with an acceptance test value of 55 percent. The decrease is due to the entry environment and sea water contamination. The 30-percent decrease agrees well with the expected results and is not significant as far as being able to see and recognize constellations is concerned. For comparison, the earth's atmosphere normally causes a 50-percent loss in star intensity; therefore, observing stars from earth with a telescope with a 50-percent transmittance would be equivalent to observing stars from a spacecraft in flight using a telescope with a 25-percent transmittance.

A heater will be added to the removable eyepiece to prevent fogging in the eyepiece assembly and on the eyepiece window.

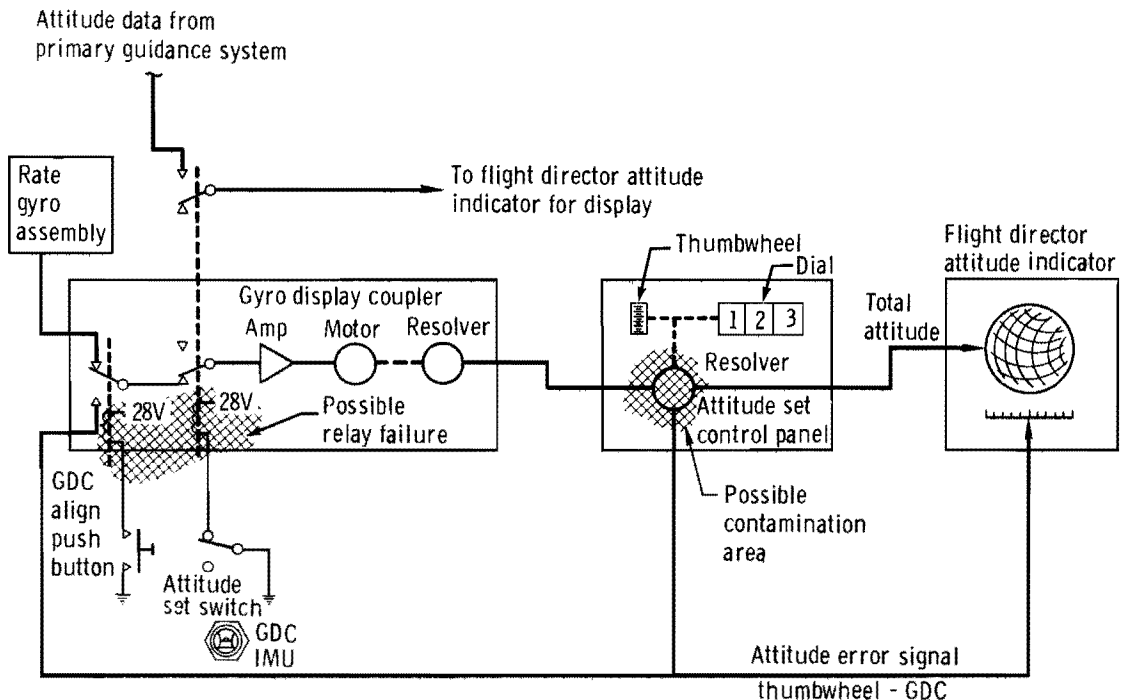
Figure 14-21.- Simplified align loop.

For normal operation during alignment, resolvers in the gyro display coupler electronics are compared to resolvers, one for each axis, on the thumbwheels used to set desired attitude. The difference is an error signal. The error is displayed on the attitude error needles, and the signal is used to drive the resolvers to match the attitude set on the thumbwheels. The anomaly could have been caused by either of two failure modes. An intermittent open in the roll axis align loop or a low gain problem in the electronics (fig. 14-21).

caused a gain type problem and been the cause of the flight anomaly. The measured resistance of the thumb wheel resolvers increased from the nominal in all three axes by as much as 1000 ohms. Normally, this value does not vary by more than 1 ohm. In order for this condition to have been the cause of the anomaly, a resistance change in the roll axis would have had to be an order of magnitude larger than that measured postflight. The resistance change is caused by contamination between the slip rings and the thumbwheel resolvers. As a result of the flight anomaly, several resolvers were examined and contamination was detected. The corrective action is to wipe the resolvers clean by rotating them several hundred revolutions. The attitude set control panels in Apollo 16 and 17 will be checked and the resolvers will be wiped clean, or will be replaced if necessary.

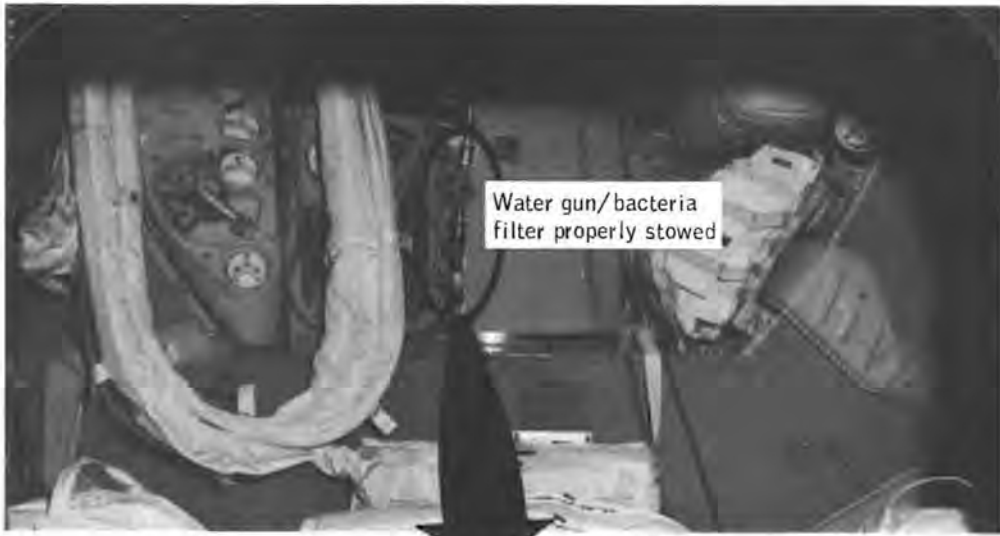
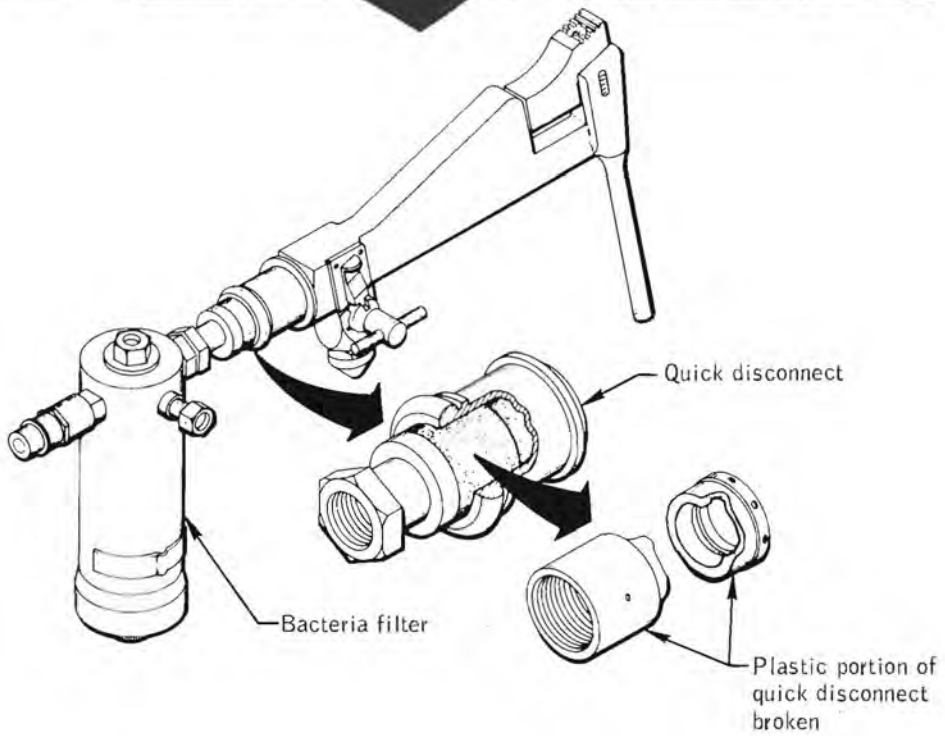
Figure 14-28.- Water gun/bacteria filter.

A water leak occurred at the quick disconnect between the bacteria filter and the water gun (fig. 14-28) shortly after the first extravehicular activity. The leak was caused by the plastic portion of the disconnect being broken and was stopped by removing the filter.

When the water gun/bacteria filter combination is properly stowed, the gun is held in a U-shaped boot (fig. 14-28). Both the gun and filter are held in place by straps with the hose protruding above the liquid cooling assembly. Bending the hose can easily exceed the force required to break the quick disconnect between the bacteria filter and the water gun if the filter is not strapped down. A test showed that a torque of 204.6 inch-pounds caused a similar quick disconnect to break in half.

Based on the torque value of 204.6 inch-pounds, a force of approximately 27 pounds applied at the hose quick disconnect interface would break the disconnect between the filter and the water gun.

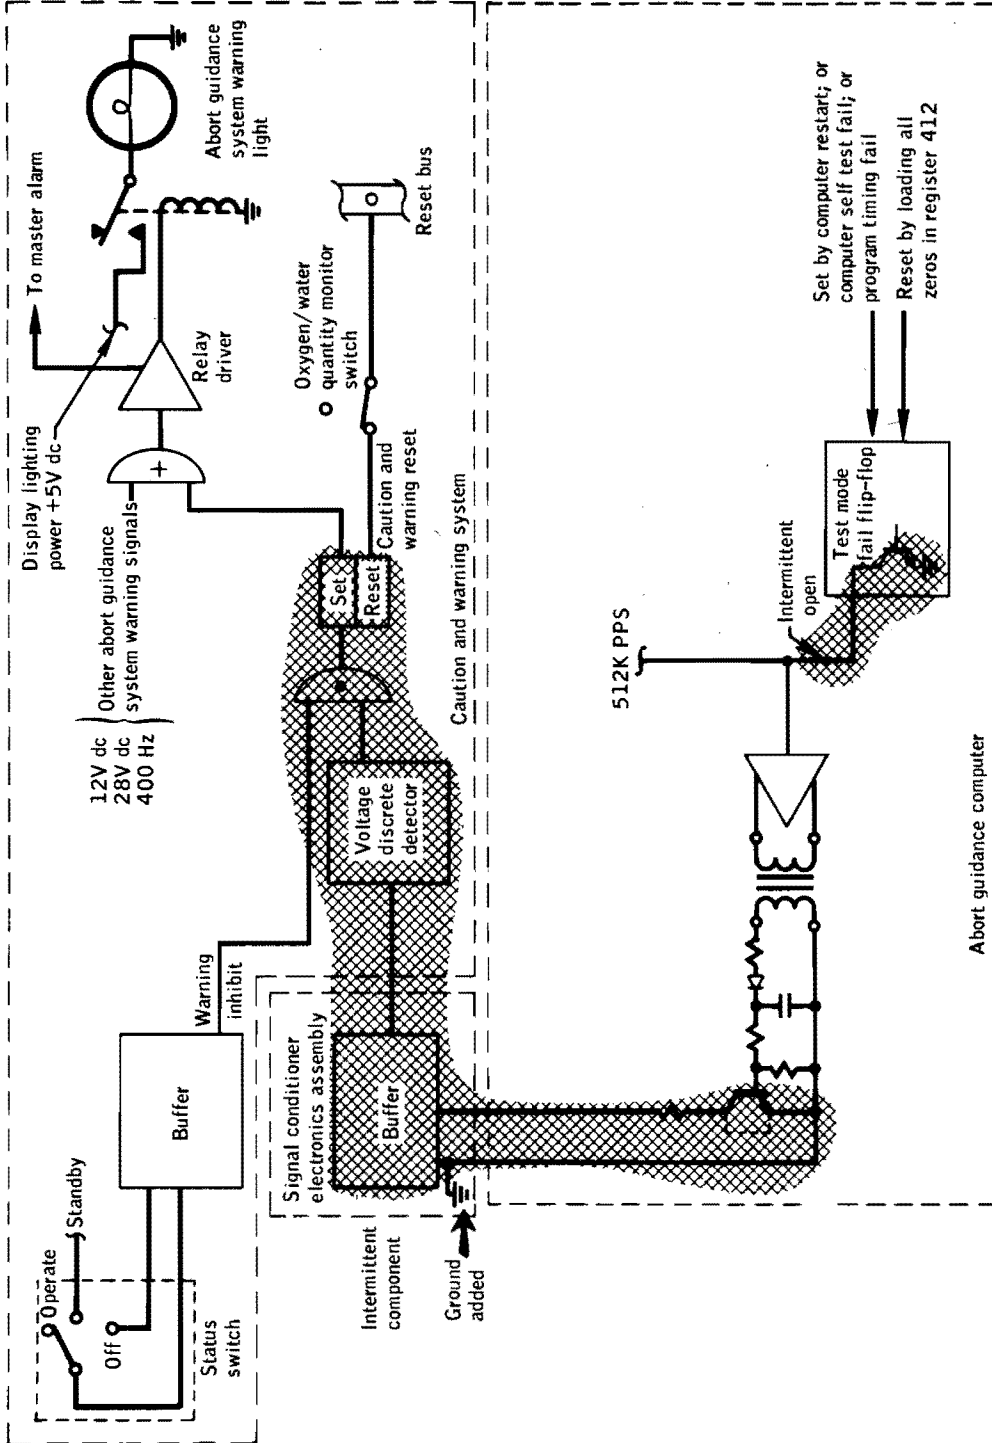
Figure 14-32.- Abort guidance system test mode fail circuitry.

The abort electronics assembly test mode fail output drives a buffer (fig. 14-32) in the signal conditioner electronics assembly which, in turn supplies the test mode fail signal to the caution and warning system. The test mode fail buffer is the only application in the lunar module where a transistor supplies the input signal to the buffer and where the low side of the input to the buffer is not grounded. Tests have shown that some buffers feed back 10-kHz and 600-kHz signals to the buffer input lines. These signals are completely suppressed when the low side of the buffer input is grounded.

For future spacecraft, the low side of the input to the buffer will be grounded.

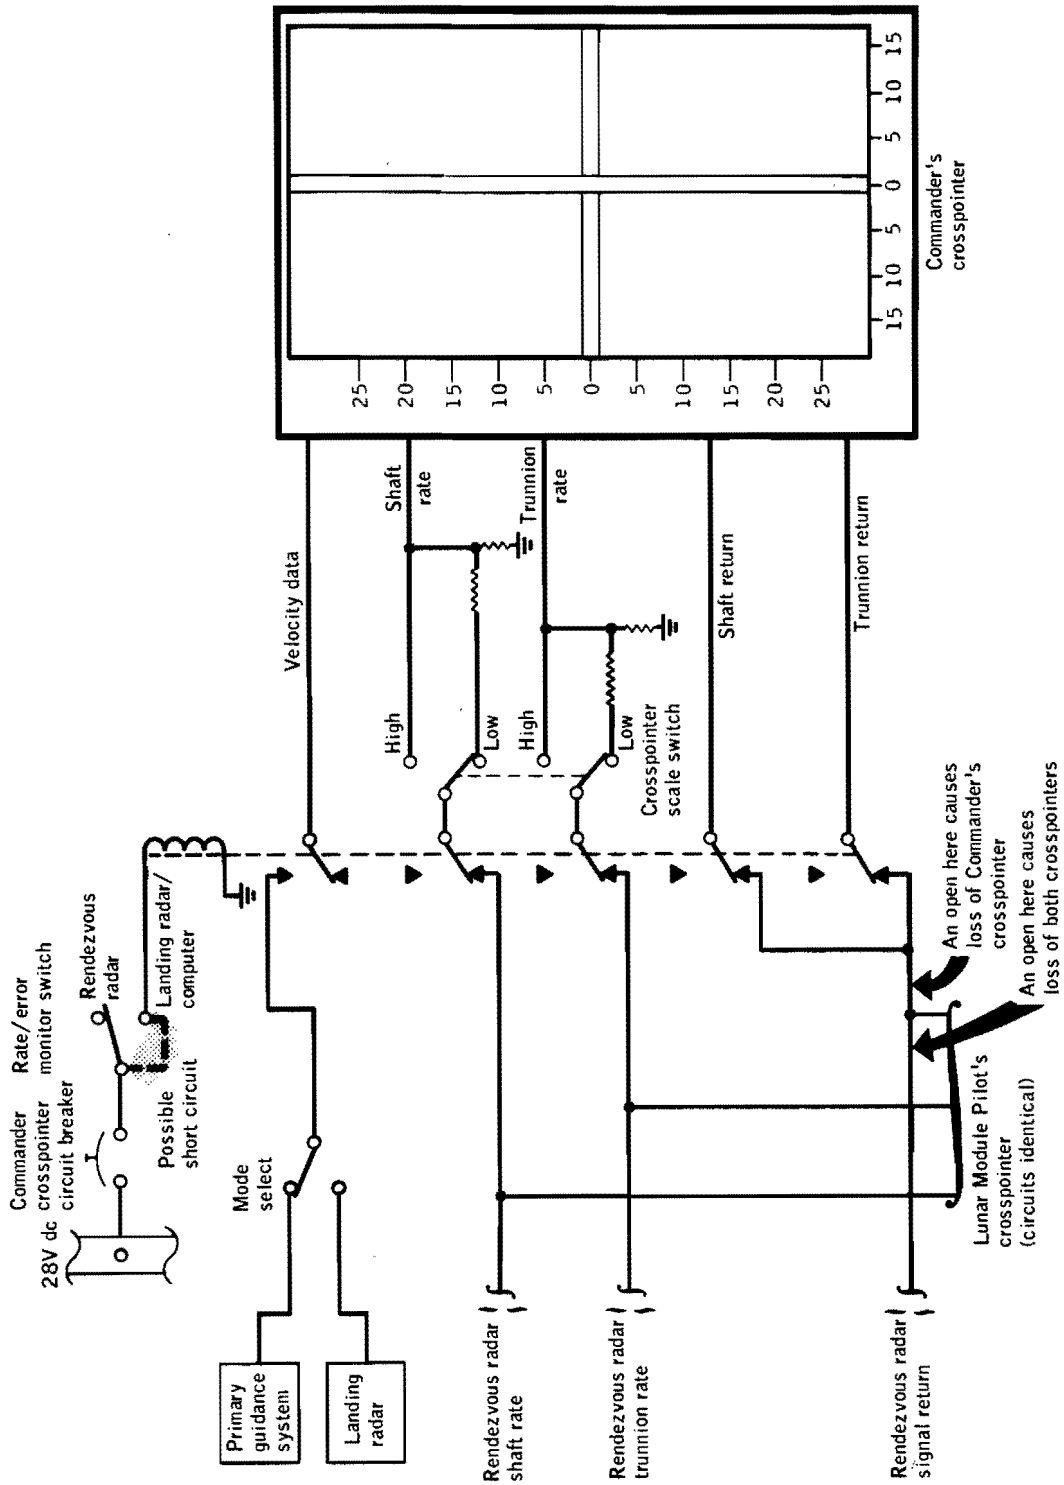
Figure 14-33.- Simplified schematic of crosspointer circuits.

Four possible conditions could have affected the display of radar antenna rate data (fig. 14-33).

c. An open in the return line would cause loss of rate data to one or both meters, depending upon the location of the open. The signal return lead from the Commander's meter in panel 1 is routed to panel 2 where it is connected to the signal return from the Lunar Module Pilot's meter and routed to the rendezvous radar.

d. An open in the wire in the rendezvous radar electronics assembly which connects 15 volts at 400 hertz to two velocity filters (one each for shaft and trunnion rate) could cause the loss of shaft and trunnion rate data to both sets of crosspointers.

The most probable failure is an open in the signal return line. Rate information could still be deduced from antenna position data which is displayed on the flight director attitude indicators. Ground tests and checkout may not show this type of failure. If the open is temperature-sensitive, a complete vehicle test involving vacuum, temperature, and temperature gradients would be required to insure that failures of this type would not occur in the flight environment. This type of testing is not practical at the vehicle level. Consequently, no corrective action is planned.

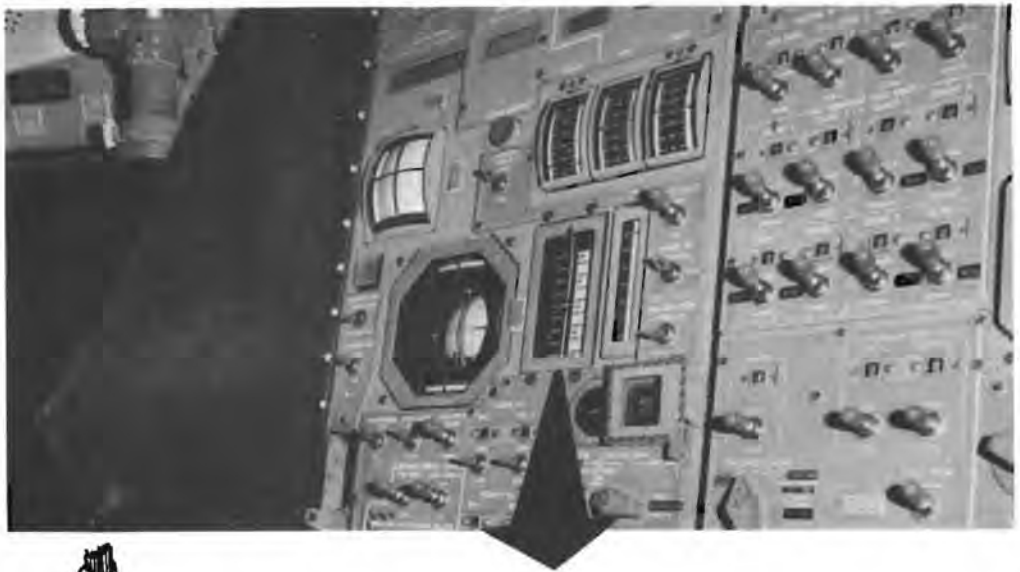
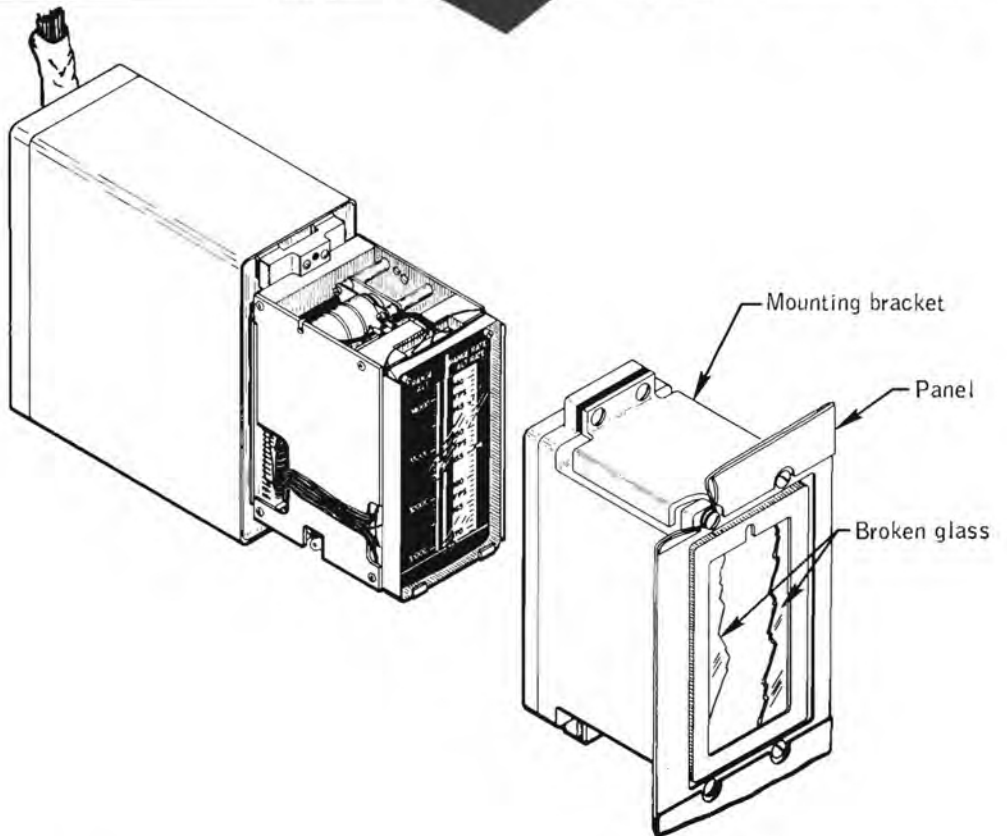
Figure 14-34.- Range/range rate meter mounting.

Sometime prior to ingress into the lunar module, the window of the range/range-rate meter broke (fig. 14-34). Upon ingress, the crew saw many glass particles floating in the spacecraft, presenting a hazardous situation.

A surface flaw deeper than the threshold depth for the glass operating stress must have existed on the outside of the meter window at launch. The flaw started growing as the cabin depressurized during the launch phase, and finally grew large enough for the glass to break.

For future missions, an exterior glass doubler will be added to the window to reduce the maximum operating stress to less than 2000 psi. This will increase the threshold flaw depth to 0.0036 inch and the critical flaw depth to 0.032 inch. This should prevent future fatigue failures since there are no reported fatigue failures in soda-lime glass at stresses below 2000 psi. In addition, all similar glass applications in the lunar

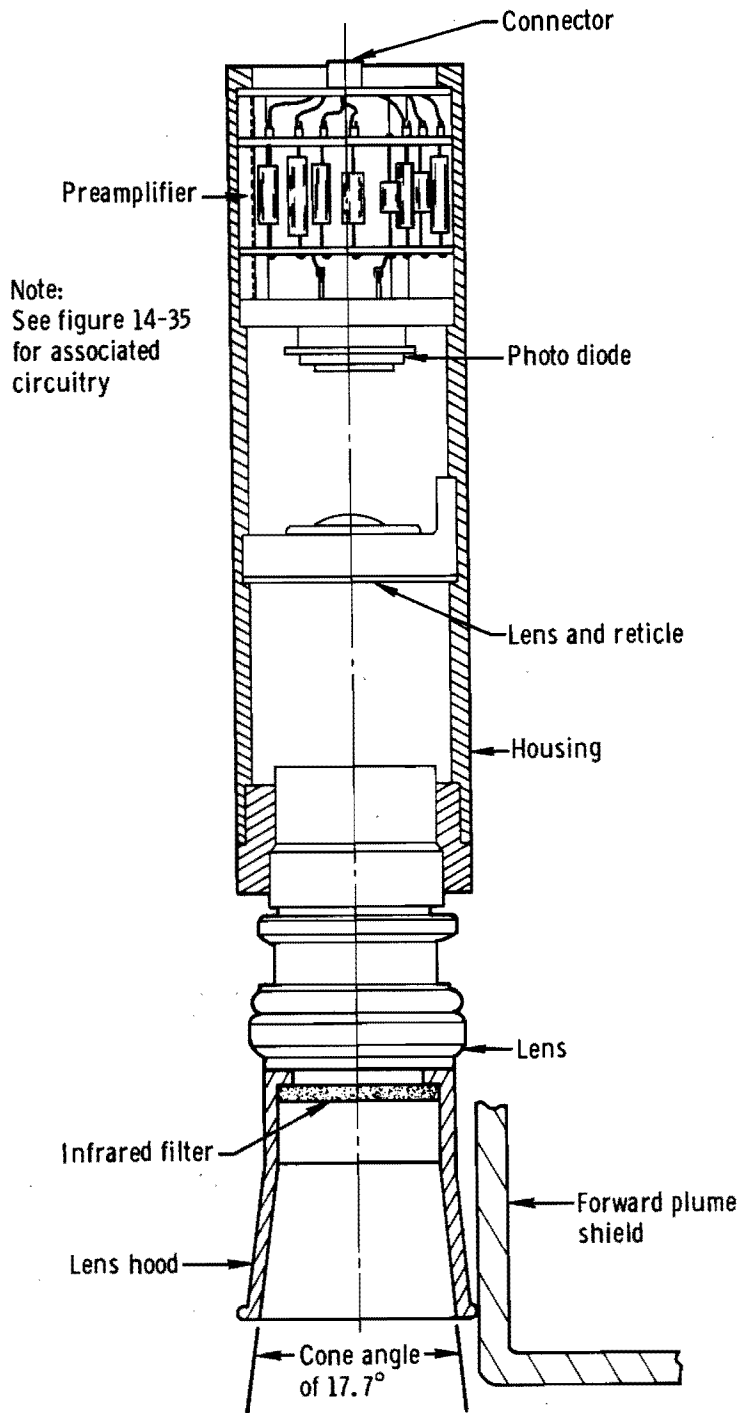
Figure 14-35.- Velocity/altitude sensor assembly.

Telemetry received from the first panoramic camera pass on revolution 4 indicated that the velocity/altitude sensor (fig. 14-35) was not operating correctly.

The results of the tests, coupled with analyses of the basic sensor design, indicate that the problem is related to the optical signal-to-noise ratio. The remaining flight hardware will be modified to improve this ratio. The optical signal will be enhanced by increasing the lens aperture from f/4.0 to f/3.5 and by deleting the infrared filter. The optical noise (reflections) will be reduced by increasing the length of the lens hood and by repositioning the sensor so that the camera's forward plume shield will not be in the field of view of the sensor. In addition, a manual override of the velocity/altitude sensor will be provided on the remaining flight units. By using a three-position switch, two preselected velocity/altitude ratios will be provided, as well as the automatic function.

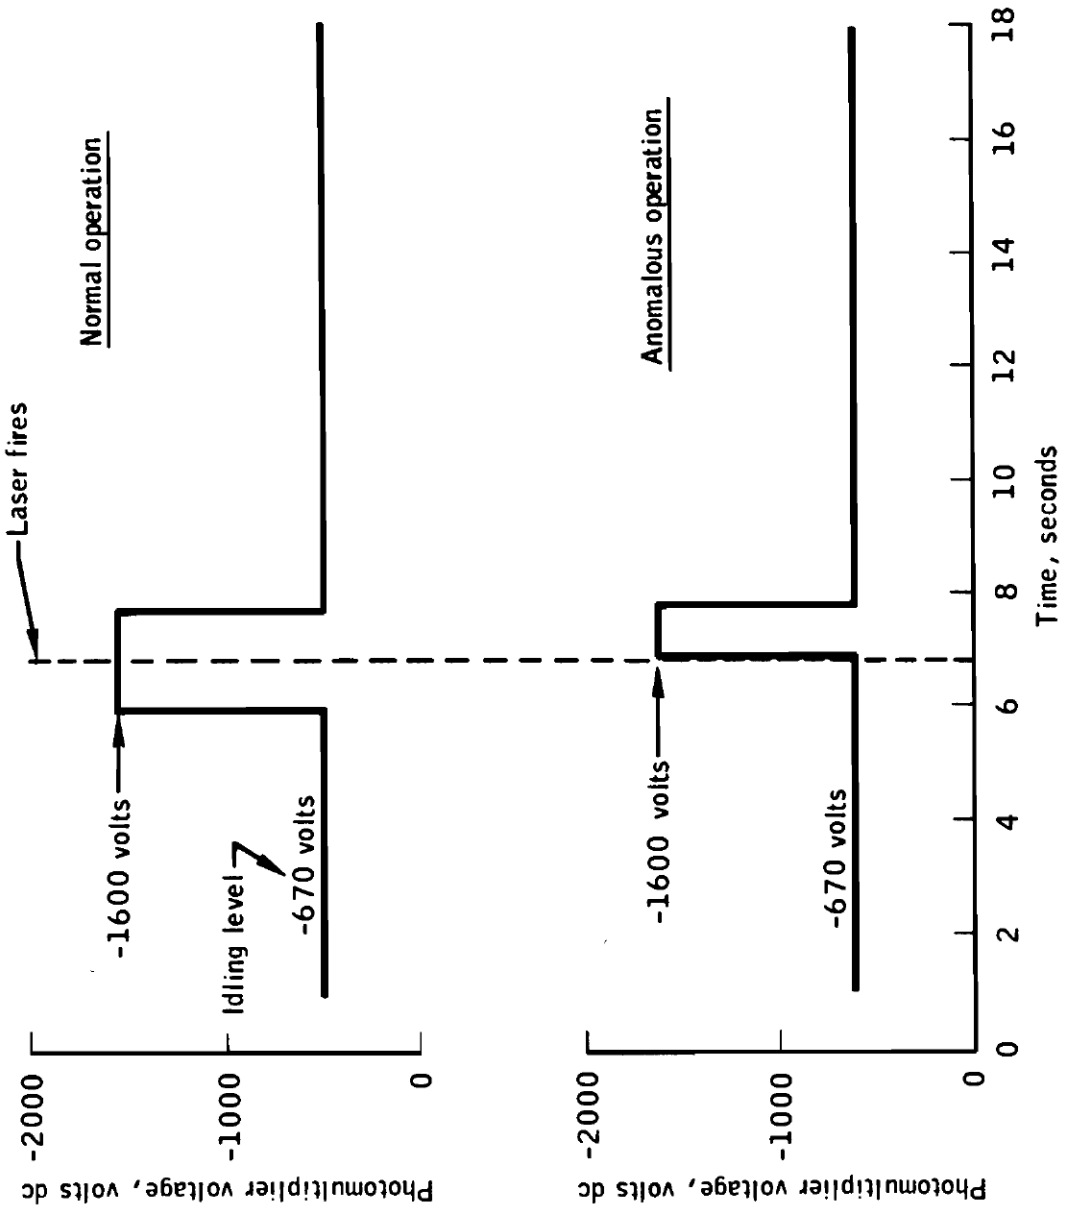
Figure 14-37.- Comparison of photomultiplier power supply voltages.

- a. Altitude data became intermittent after revolution 24 as the result of a decrease in the laser output power.
- b. Beginning with revolution 38, the photomultiplier tube high-voltage power supply was held in the idling (minimum-voltage level) mode until after the laser fired, thereby causing the receiver to miss the return pulse from the lunar surface (fig. 14-37). No altitude data were obtained after this anomaly occurred.

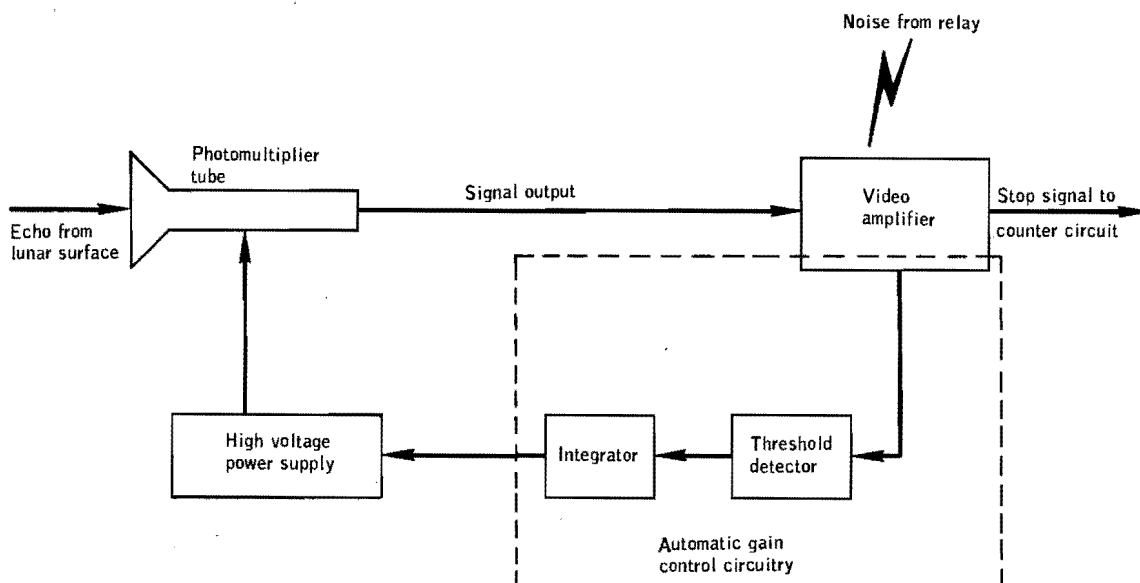
Figure 14-39.- Laser receiver circuitry.

It is suspected that the audible "buzz" is accompanied by electromagnetic interference that is coupled into the video amplifier in the laser receiver (fig. 14-39). The video amplifier is a principal element in the automatic gain control circuit which controls the output of the photomultiplier tube power supply. The electromagnetic interference from the relay can thereby result in the automatic gain control holding the power supply in the idling mode until the pulse forming network is discharged in firing the laser. The relay and resistors that comprise the bleed-down circuit will be removed from the remaining flight altimeters.

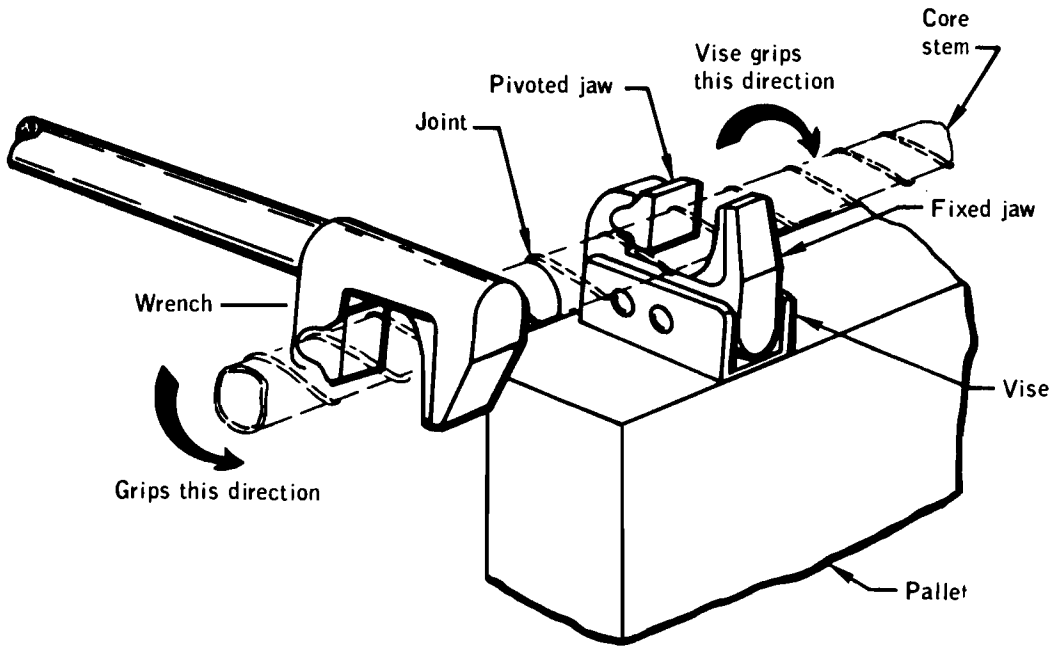
Figure 14-44.- Installation of core stem vise on rover pallet.

As mounted, the vise would hold the core stem so that the joint could be tightened by rotating the wrench on the adjoining section. However, the vise would not hold in the opposite direction so that the joint could be loosened and separated (fig. 14-44). Working on the inboard side of the vise, the core stem could have been held properly for loosening; however, there is insufficient clearance on the inboard side of the vise for wrench rotation, and the distance to the other side of the lunar roving vehicle is greater than the length of a core stem section.

The installation drawing of the vise was in error and has been corrected to assure correct orientation of the vise for Apollo 16. The training vise was installed backward from the erroneous drawing, but correct for loosening the stems.

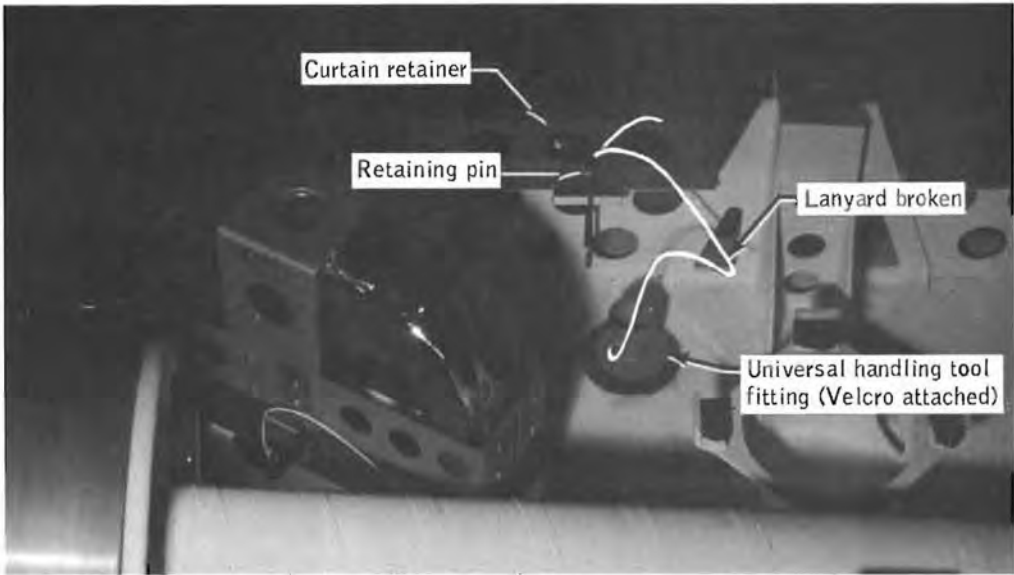
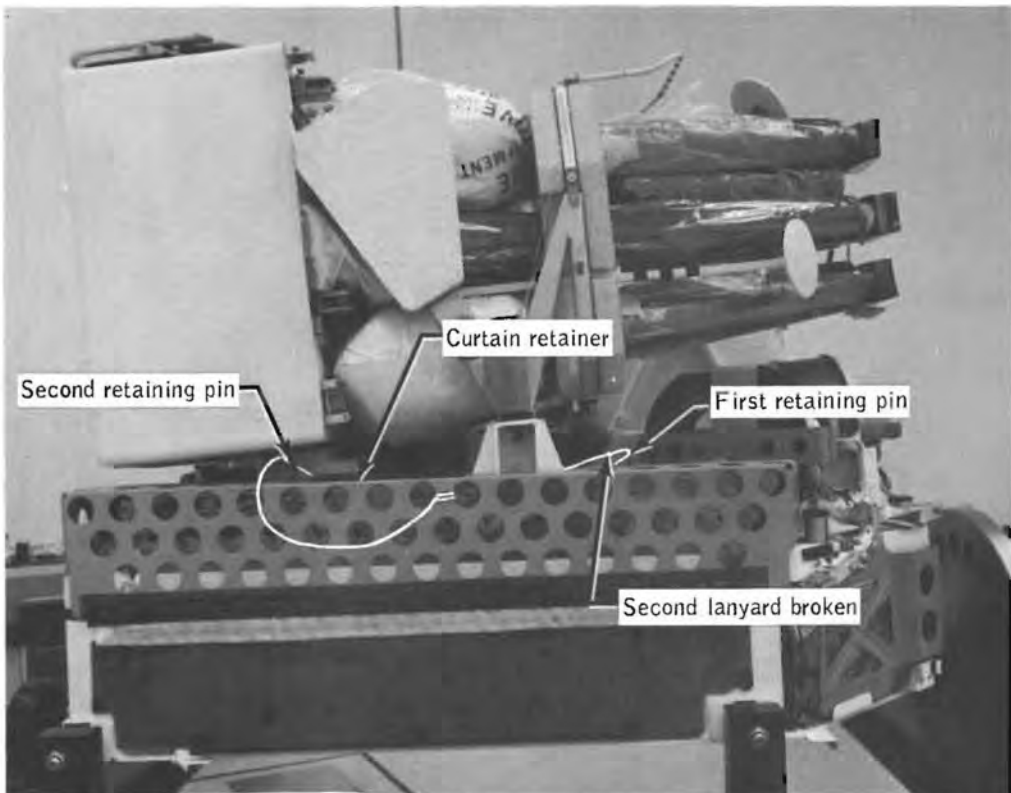
Figure 14-45.- Central station rear curtain retainer removal.

To remove the retainer for the central station rear curtain, added for Apollo 15, it was necessary to remove two retaining pins (fig. 14-45). The two pins, a universal handling tool fitting, and the curtain retainer are joined by a three-section lanyard. When the universal handling tool was inserted in the fitting and raised to remove the first pin, that section of the lanyard broke. When an effort was made to remove both pins simultaneously by inserting the handle under the lanyard joining the two pins, that part of the lanyard broke. The pins and retainer were then removed by hand.
